Dropped object near miss – hammer dropped from scaffolding

Safety Flash Published on 23 August 2017 Generated on 28 January 2026 IMCA SF 21/17

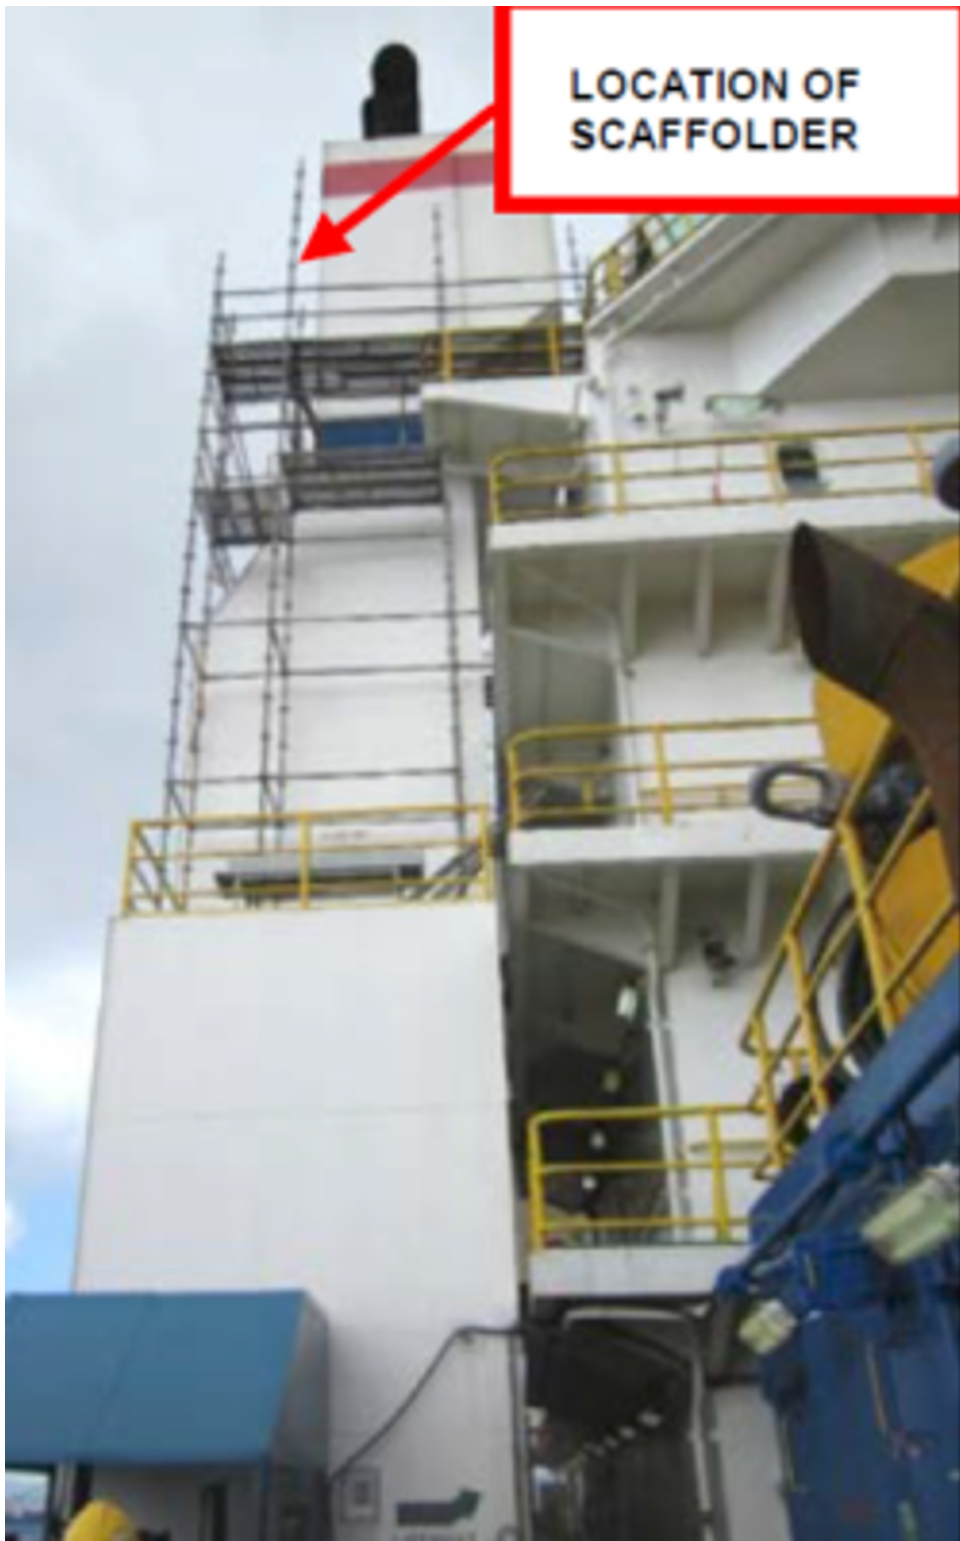
**LOCATION OF
SCAFFOLDER**

Third party scaffolders were erecting scaffolding along the funnel of a vessel. At the time of the incident, the decks below where the scaffolders were working were barriered off as required by the risk assessment. When moving from one level to the next, a hammer caught on the floor plate and was tipped out of the scaffolder's belt loop. The hammer slipped free from the attached lanyard (see photo), fell and bounced off the handrail of one of the lower decks and came to rest *outside the barriered area* on the forecastle deck. No-one was harmed.

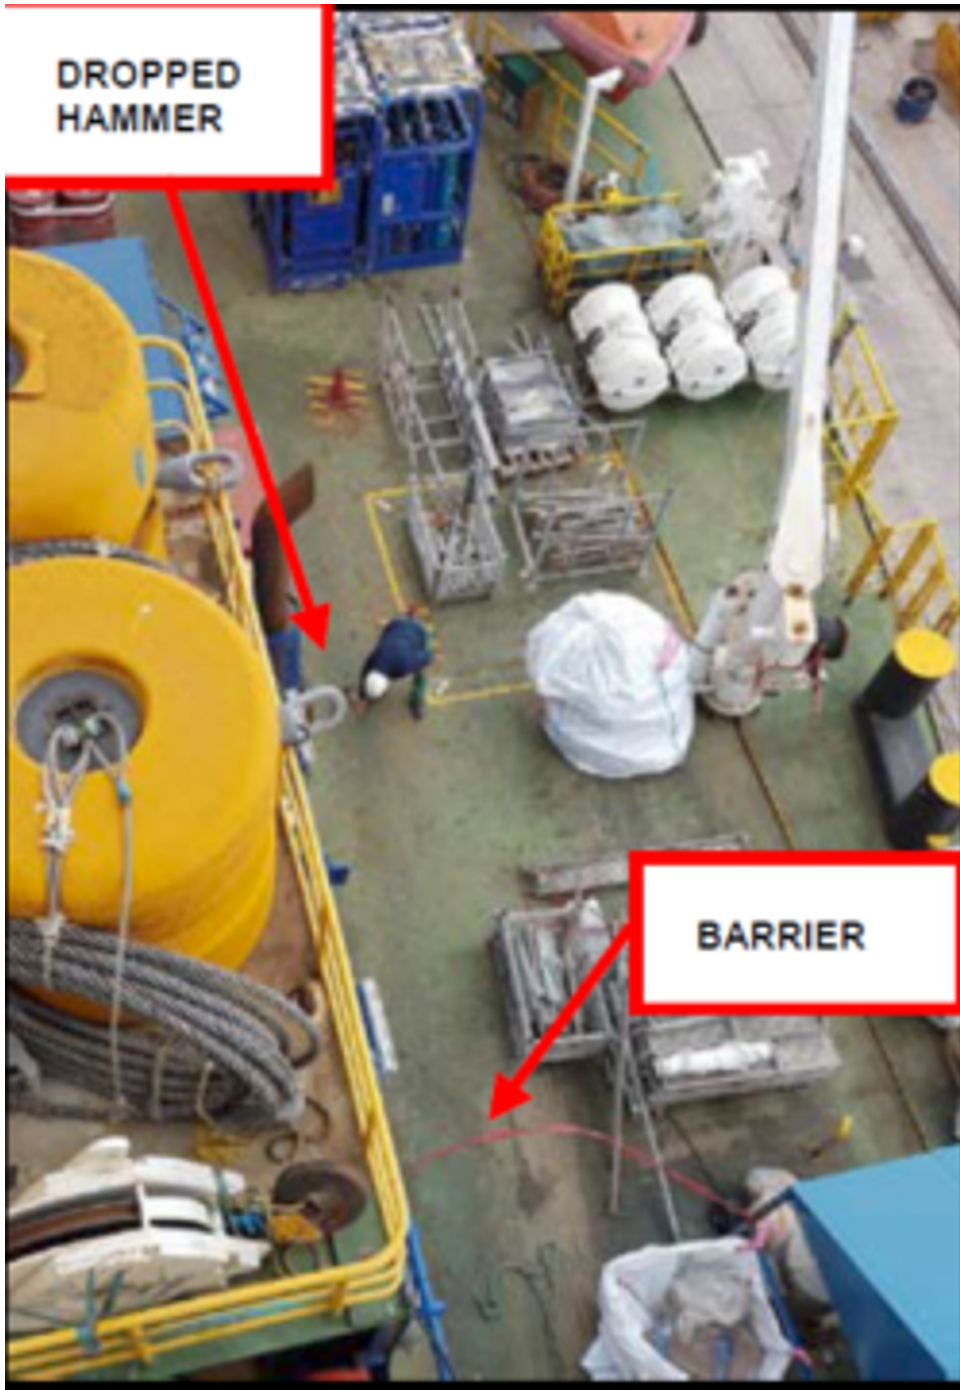
- The lanyard and hammer were not suitable to be used together.
- Due to the inexperience of the scaffolding contractors with working at height tooling, the scaffolder and supervisor did not identify the issue.
- **The barriers were insufficient** – they were not wide enough and were not in line with the “cone of exposure” guidance provided in the dropped object prevention procedure.

**DROPPED
HAMMER**

BARRIER

- Members may wish to reiterate:
 - the importance of the "cone of exposure" when dealing with dropped object protection, and ensure that this is discussed and given careful consideration
