High potential near miss: dropped object – buffer plate fell from crane boom

Safety Flash Published on 23 August 2017 Generated on 24 January 2025 IMCA SF 21/17

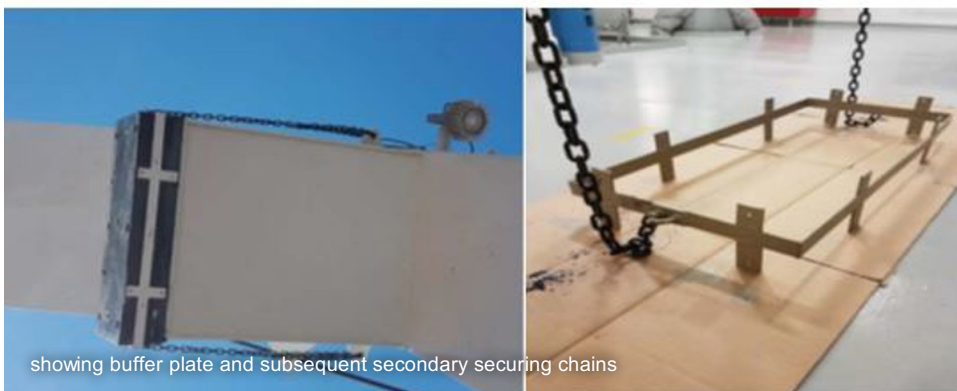
The buffer plate fell approximately 10 m, weighing 70 kg and was 90 cm x 40 cm. It landed inside the barriered off area on the back deck; there were no personnel nearby. Clearly this could have been a potential fatality had someone been struck by the plate. The purpose of the buffer plate is to be a buffer between the jib and the boom so the steel is not damaged.

- The **immediate cause** was found to be that the bolts holding the buffer broke due to metal fatigue.
- The **root cause** was found to be inadequate or insufficient planned maintenance/inspection. Fatigue in the bolts had been allowed to develop over several years in operation as there had been no proper inspection of the bolts. It was not possible to see damage to the bolts during the visual inspections of the crane which were regularly carried out.

- The bolts used subsequently to re-attach the buffer plate were increased in size from M12 to M14.

- Secondary securing of the buffer plate was installed to prevent it from falling.
- On all the members' vessels with similar cranes, the planned maintenance system was modified to include maintenance/inspection of the buffer plate including bolts.
- A DROPS check of all cranes was made in order to assess for potential dropped objects during operation.
