## Uncontrolled movement of crane block and pennant during lifting operations at sea

Safety Flash Published on 23 August 2017 Generated on 14 January 2025 IMCA SF 21/17

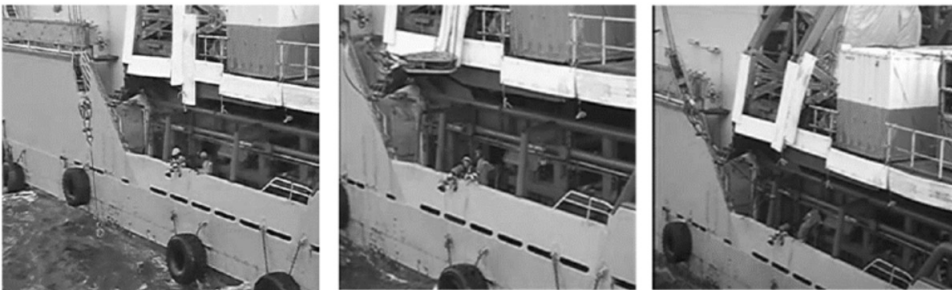
The receiving vessel's crane was positioned along the supply vessel's port side where deck crew were waiting to secure and connect the hose to the rigging. The supply vessel rolled to Port due to sea swell. This caused the crane's auxiliary hoist block to make contact with the supply vessel's ROV launch and recovery system platform, which in turn caused the hoist block and attached pennant to swing.

While swinging, the pennant and hook made contact with the work station close to where the supply vessel's deck crew were stationed. Following the incident, an **All Stop** was called. After the task was reassessed, the supply vessel proceeded to re-route the hose along the main deck. The operation was successfully completed.

- Before starting the operation, the following requests were made:
  - Route the hose along the main deck aft instead of the port side – rejected by the supply vessel crew.
  - Use a longer pennant to increase the distance between block and the intended load – rejected by receiving vessel crew who felt the longer pennant would increase potential swing.
  - Before transferring the bunker hose, the supply vessel requested that the receiving vessel make a heading change to reduce thruster wash as it was making it difficult to maintain station. The heading was changed, station keeping stabilised, and control of the operation was handed to the

- The two vessels had never previously conducted bunkering operations together.
- There was minimal communication between the vessels before the job started. The only discussion was regarding the length of the hose (60 m required by receiving vessel, as opposed to supply vessel's suggested 30 m).
- There was no comprehensive planning or control of work between departments on board the receiving vessel:
  - Engine control room raised a permit to work with a risk assessment covering the operation, no deck officers or deck crew were included in the toolbox talk or signed onto the permit.
  - The permit to work was generic for cargo operations.

- Activities involving different departments should be jointly and thoroughly planned with clearly defined roles and responsibilities.
- Operations involving crews unfamiliar with one another (as on visiting supply vessels, etc.) should be fully planned in advance.
