Davit failures

Safety Flash Published on 4 September 2019 Generated on 28 January 2026 IMCA SF 21/19

A member reports two recent issues relating to the davits of small boats

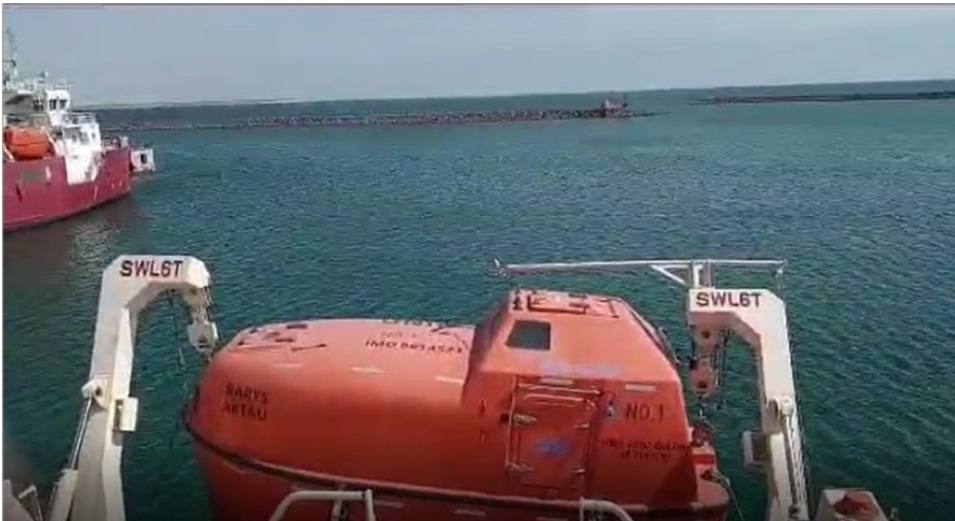
- During routine inspection of the rescue boat equipment and davit swing, it was noted that the davit would not swing out. This was due to a malfunctioning hydraulic pump not building up pressure.
- During a weekly technical inspection of lifeboats and davits, a delay in response of the aft davit was noticed whilst swinging in the starboard lifeboat to the stowed position. After a few unsuccessful attempts, the hydraulic accumulator valve of the forward davit was changed over to 'evacuation mode' in order to direct hydraulic oil to the hydraulic cylinder of the aft davit only. After that, the aft and forward davits came back to the stowed position at the same time.

- In both cases equipment failure.
- The faults were observed in routine planned inspections of the equipment, which emphasises the importance of conducting inspections and planned maintenance.
