## High potential near miss – Rescue boat davit failure (MSF)

Safety Flash Published on 4 September 2019 Generated on 16 January 2025 IMCA SF 21/19

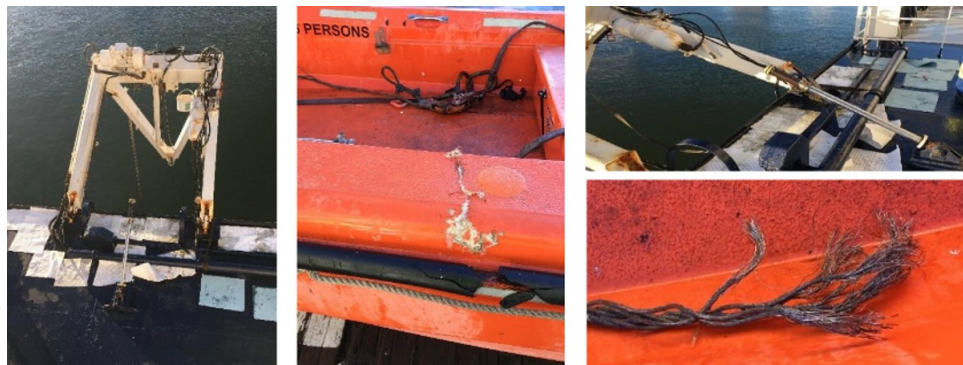
During the swinging out and lowering of the boat, the davit moved uncontrollably to the full extent of the piston, at which point the piston end cap separated from the piston and the davit carried on falling to the deck. On coming to a stop at the deck, the shock loading of the fall wire caused it to part and the rescue boat fell into the water.

The davit manufacturer and a local hydraulics expert were both unable to confirm the exact cause of the initial failure - however, a failure of one of the counterbalance valves or failure of the end cap itself were noted as the most probable first point of failure.

- The vessel owner made it mandatory for vessels to complete an unmanned test lowering of the davit and boat, function testing all controls, before conducting manned launch.

- Replacement of fall wires on rescue boats at 30-month intervals.
- At the five-yearly thorough examination, maintenance and testing of the rescue boat and davit, replacement of the counterbalance valves and piston end cap.
- Review of the maintenance and inspection requirements within vessel planned maintenance system (PMS) to ensure alignment with the manufacturer's recommendations.
