American P&I Club: Vessel grounding – fatigue was a factor

Safety Flash Published on 26 September 2022 Generated on 21 January 2025 IMCA SF 21/22

The American P&I Club, as part of its “Good Catch” safety series, has published a bulletin relating to a towing vessel grounding in which fatigue was a factor.

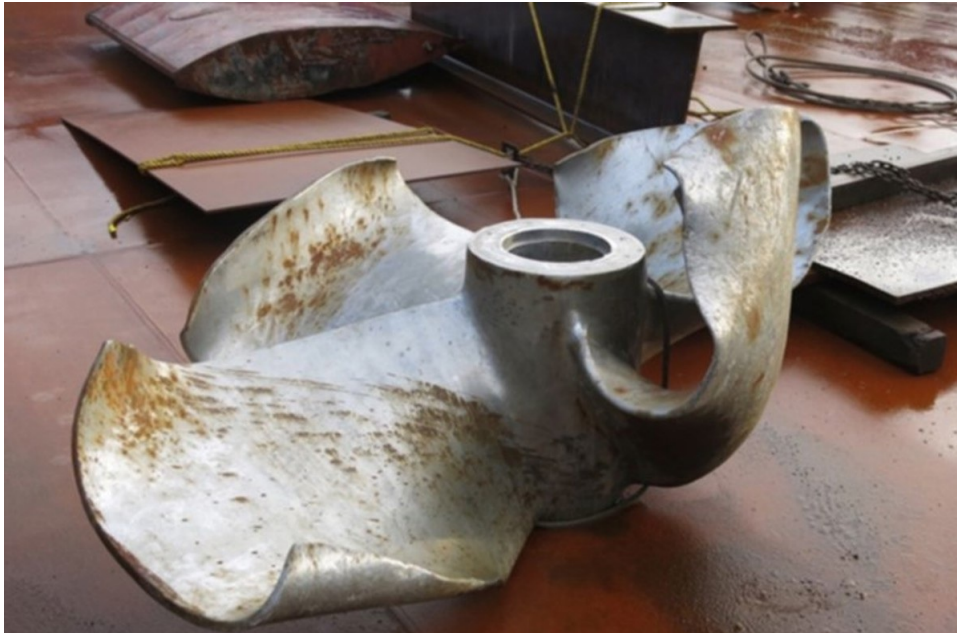
A towing vessel was on a coastal voyage pulling a large deck barge. The vessel had departed port earlier that morning after a very busy night loading and securing cargo on the barge. Cargo loading was not completed until 2:00 am and all of the cargo was confirmed to be properly secured by 6:30 am. The towing vessel got underway shortly thereafter.

At approximately 1:25 am, the towing vessel ran aground on the shoal. The grounding caused both main engines to shut down. The engineers were unable to restart either main engine and suspected damage to both propellers and shafts. Both ducted propellers were heavily damaged. The towing vessel was out of operation for 10 weeks. Repairs cost over \$950,000. The vessel itself could easily

have been lost had the hull been breached, or had one of the propeller shafts been seriously compromised.

- The Mate fell asleep in his chair on watch. He indicated that a combination of the previous sleep disruption, extra work the night prior, and very calm seas caused his fatigue.

- The Mate also indicated that he did not set an alarm in the ECDIS to remind him of the planned course change nor did he set up depth contour alarms. He said he was familiar with how to do both, but it had not been their standard practice onboard this vessel.

- Except in emergencies, the requirements for adequate rest should never be ignored for the sake of operations.
- Records of hours worked should be honestly filled out and maintained. Recordkeeping associated with work and rest should be made part of the culture onboard each vessel and part of the vessel's safety program.
- Mariners on watch who are having difficulty staying awake should recognize that the safety of the crew, the vessel and the cargo is at risk. They should either take direct action to maintain their alertness (stand up, move around, call a deckhand to come to the bridge, have a cup of coffee) or call the Master and ask for assistance.
- ECDIS alarms are valuable tools that should be fully used and correctly

set.
