Crewman badly scalded during tank cleaning

Safety Flash Published on 1 September 2016 Generated on 14 January 2025 IMCA SF 22/16

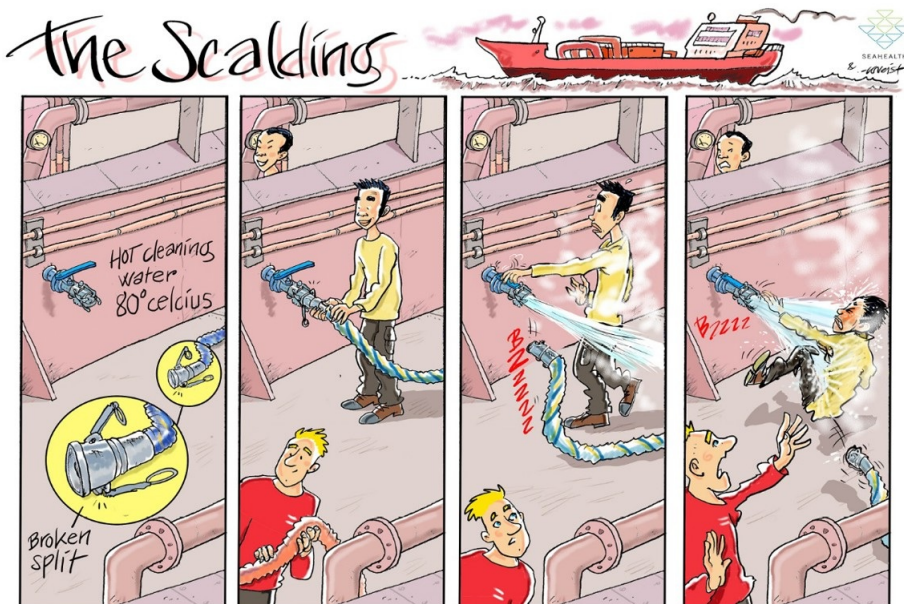
The incident occurred during hot water cleaning on lube oil tanks, when cleaning machines were exchanged between sequences of cargo tanks. When changing sequence, the tank cleaning hose, when pressurized, opened up and hot sea water released freely from the line. The injured party was positioned alone right in front of the hydrant and not expecting the failure. None of the crew saw what caused the failure, but they noticed steam clouds from hot water coming off the hydrant and the injured person next to the hydrant.

Investigation revealed that the most likely cause was that the securing mechanism/locking mechanism for the camlock coupling was either defective or not properly locked, leading to the coupling to break off when pressure was applied. When the hose was found, after it had gone off the connection point, one of the locking handles was found broken off; the shaft missing and the gasket was found on the deck.
