## High Potential Near Miss: Line of Fire During Mooring Operations

Safety Flash Published on 25 September 2018 Generated on 24 January 2025 IMCA SF 22/18

**A seafarer was caught in the line of fire and temporarily trapped by a mooring line, but fortunately escaped without serious injury.**

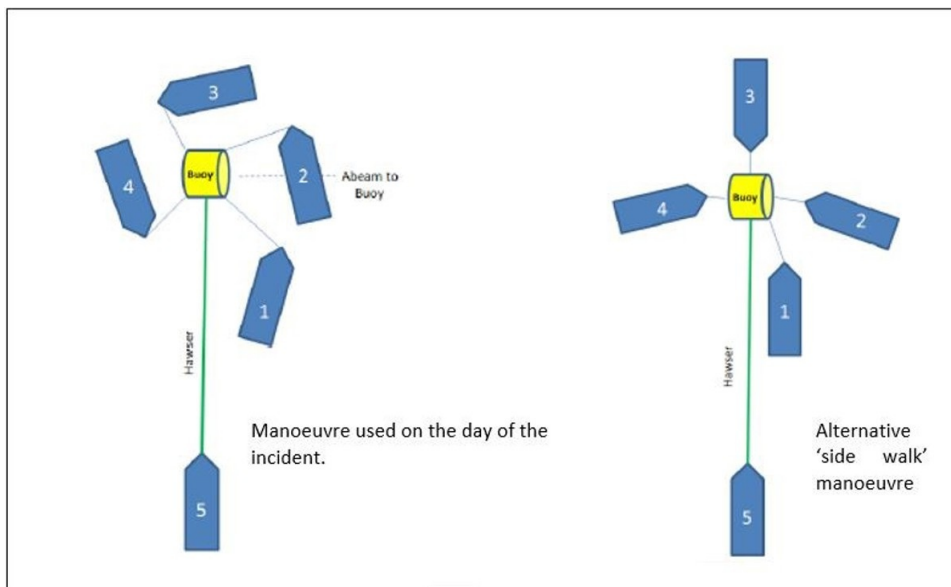
During the mooring of an offshore support vessel at a sea mooring, the crew noticed that the hawser had become fouled. The chief officer, who was in charge of the watch, decided to manoeuvre the vessel around the buoy to ensure that the line would provide a clear lead once the hawser had been made fast. After securing the hawser to the mooring bits, the chief officer started manoeuvring the vessel around the sea buoy in an anti-clockwise direction. He was not aware that a seafarer was still located on the foredeck area, coiling a grapple rope.

As the vessel was manoeuvring around the buoy, the swell and sea state affected the vessel's rate of turn, causing it to move ahead rather than turn as planned. This subsequently resulted in the direction of the mooring buoy to lead aft of the vessel's port beam and place the hawser line under tension; the taut line slipped over the bow fender and bulwarks arrangement and pinned the seafarer against the handrail of the stairs for approximately 4-5 seconds. The vessel moved in the seaway; the line tension subsided, and the seafarer was freed. He escaped serious injury but experienced some post-event shock and localised bruising and pain.

- The design of the sea buoy allowed the floating hawser and messenger to become fouled when floating free.
- The location of the sea mooring was subject to strong and fluctuating currents (a replacement low profile sea buoy was ready to be deployed upon the vessel's next arrival in port).
- The chief officer believed the foredeck to be clear of personnel immediately before starting his manoeuvre around the sea buoy to clear the hawser.

The conning position at the forward console has inherent blind spots, caused by vertical window stanchions, which prevent an uninterrupted view of the foredeck area unless the person manoeuvring the vessel moves his field of view;

- Confirmation by very high frequency (VHF) radio that the deck was clear, was not obtained.
- The vessel manoeuvre used to un-wrap the hawser from the sea buoy had the potential to place sudden tension on the hawser line as the vessel rotated around the sea buoy. It also had the potential to place an adverse lead on the line from the vessel's central panama lead.

- A new low profile sea buoy has been deployed that is more suitable to areas experiencing strong and fluctuating currents.
- A strict clear deck policy has been enforced for future operations involving vessel manoeuvres while attached to a mooring hawser, including VHF communications confirming that the deck is clear prior to commencing the manoeuvre.
- A toolbox talk (TBT)/job safety analysis (JSA) review will be held prior to manoeuvring the vessel around a sea buoy that emphasises the clear deck policy and VHF confirmation.
- An alternative method, used by other persons performing the manoeuvre in previous occasions, involved using the azimuth drives to 'side walk' around the buoy, while keeping the buoy facing the bow and not under tension. This method would be used henceforth.
