## Dropped wooden block in conductor support frame

Safety Flash Published on 17 September 2019 Generated on 28 January 2026 IMCA SF 22/19

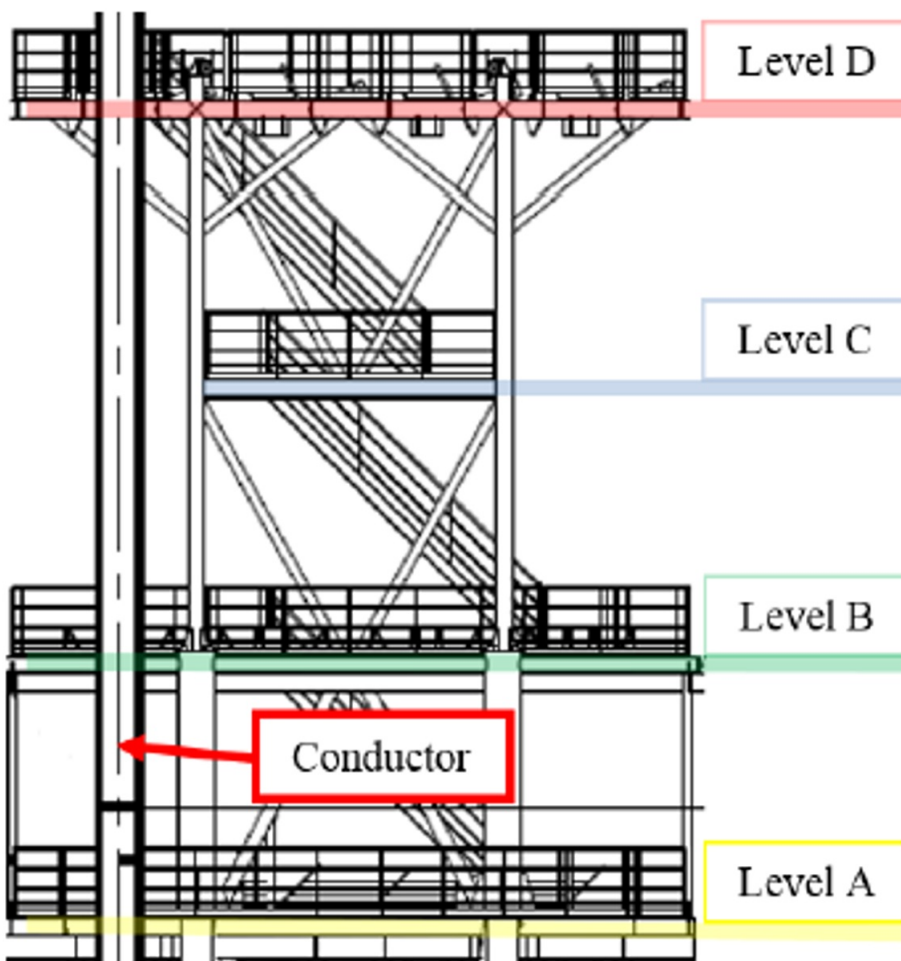
The rigger suffered minor cuts; it was fortunate that his injuries were not more serious. The incident occurred during decommissioning operations using a conductor support frame (CSF) to help with the removal of conductors.

Conductors were pulled into position in the CSF by crane. To reduce horizontal movements, wooden wedges were installed, whilst the conductors were being cut in smaller sections. During removal of the wedges, one of the wedges fell and struck the rigger.

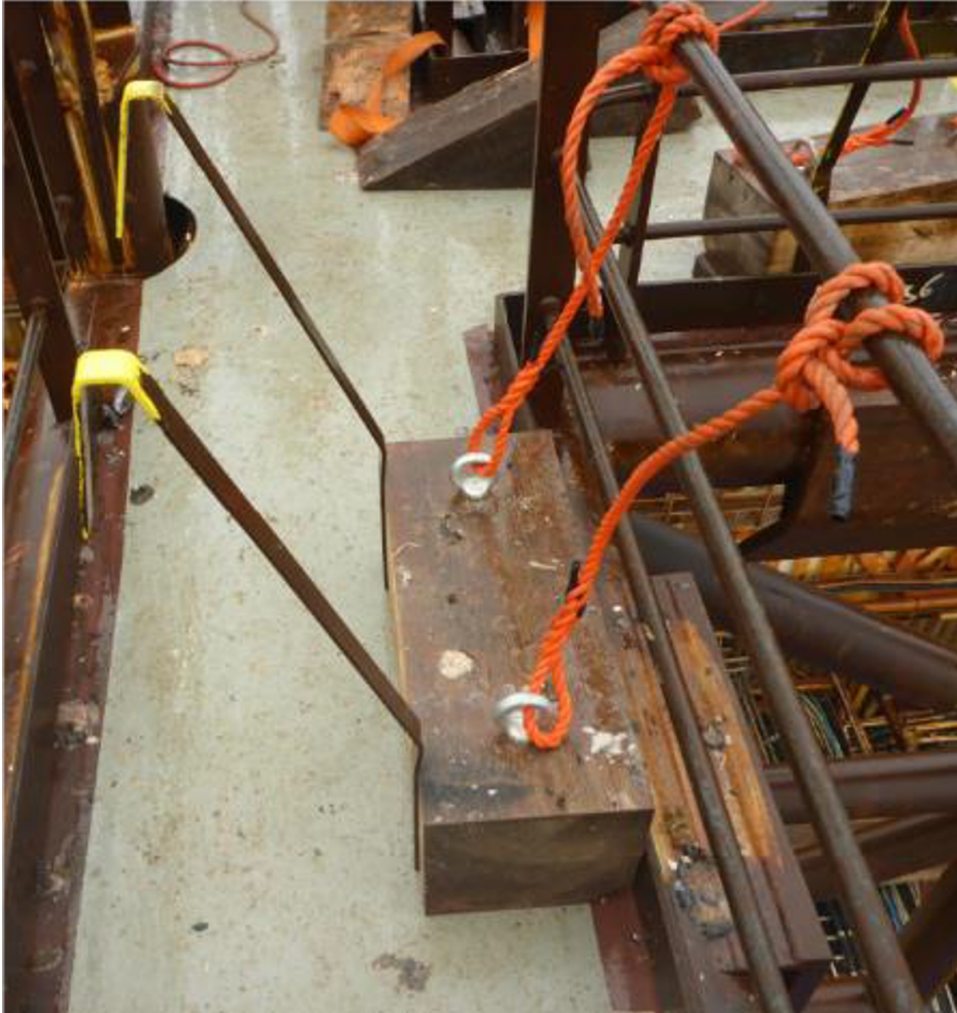
As per company procedure, the wedges were to be placed into position at level B, to remove any horizontal movements of the conductor. To reduce movements from the top of the conductor, additional wedges were installed at level D (top level) of the CSF; *this addition was not part of any procedure.*

After completion of the sectioning cut at level A, the rigging team started to remove the wedges installed at level B, as per original procedure. Whilst removing the wedges at level B, one of the wedges installed at level D dropped to level B striking one of the riggers.

- Procedures had not been updated to include the additional wedges at level D.
- Management of change (MoC) was not implemented/followed.
- There was a failure of the wedge securing eyes due to vertical movement of the conductors caused by vessel/platform movement.
- It was not identified that removal of the (upper) level D wedges prior to removal of the (lower) level B wedges would have eliminated the dropped object risk.

- Any change to a procedure should be subject to MoC.
- Procedures should be updated immediately and re-issued to include any changes.
- Any changes to procedures should be communicated to all personnel potentially affected by the change.
- All persons involved should take part in risk assessments/job safety analysis (JSA) in order to ensure all hazards are identified and eliminated/controlled.
