## LTI: fractured finger during anchor handling

Safety Flash Published on 3 October 2022 Generated on 28 January 2026 IMCA SF 22/22

A crew member suffered a serious finger injury when he got his finger trapped.

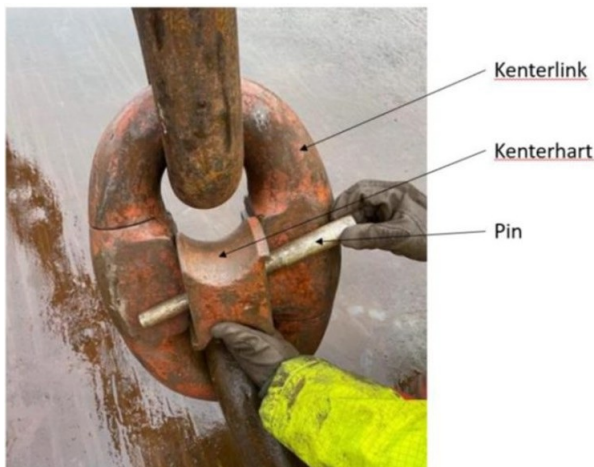
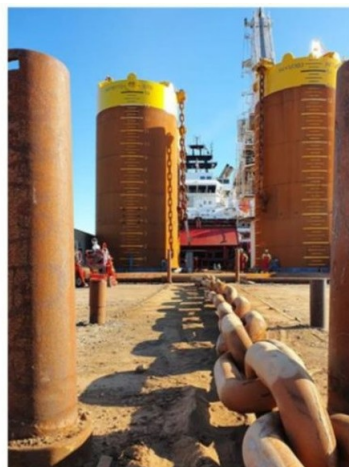
Suction Anchors and Mooring Chain

The injured person was sitting on deck hitting the Kenter heart down to drive out the pin. The pin is a conical shape, and so it must be done the correct way or else it will be driven firmer into the Kenter heart. If this is done the correct way, the pin comes out easily. While he was hitting the heart with the pin down to a hard surface the wrong way, it didn't loosen but slipped and his finger got squeezed/pinched between the deck/chain and Kenter heart.

Lack of training & knowledge – the injured person had previous experience on deck on various vessels, but was new to this vessel and anchor handling operations. While he had received training and he was supervised working on the aft deck. He did not know about the conic shape of the pin in the Kenter heart.

Insufficient supervision – whilst there were personnel working around him on deck and he was a part of a “buddy” system, he was not being overseen at the time of the incident;

Lack of effective risk assessment – the risk assessment for the specific job was done in the beginning of the campaign *before the injured person was onboard*. The team did not effectively perceive the risks in the situation and the injured person did not stop to get advice from his colleagues.

- A higher focus on training and supervision of inexperienced or new

personnel.

- Communicate incident effectively: New employees represent an increased risk of injuries and need special attention during their first shifts and time onboard. Increased activity in general, also means increased number of new employees onboard the vessels.
- Could impact gloves be helpful in some operations on deck?
