Crane contact with pipelay tower resulting in dropped object

Safety Flash Published on 19 August 2021 Generated on 22 January 2025 IMCA SF 23/21

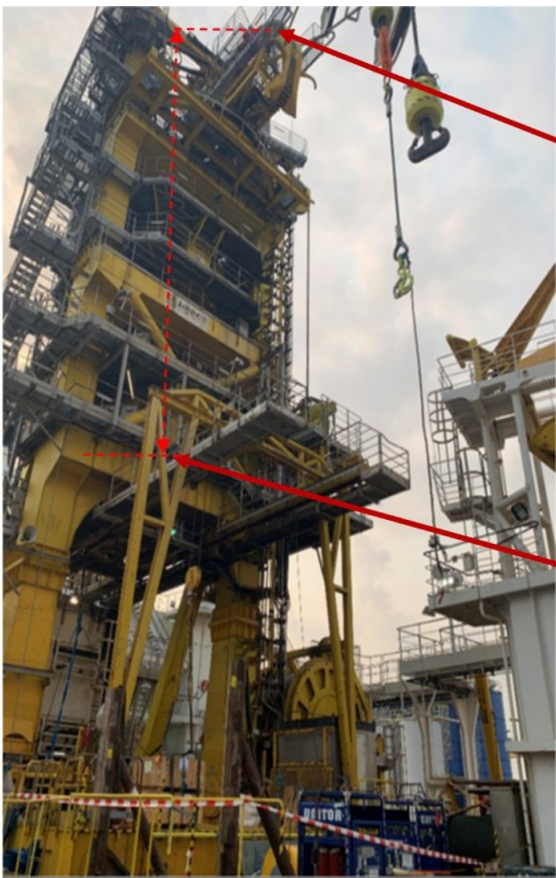
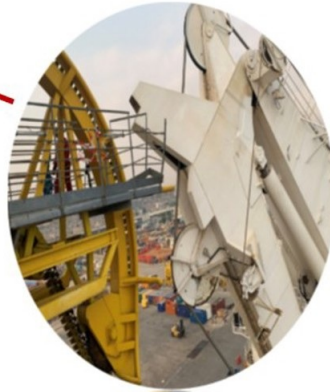
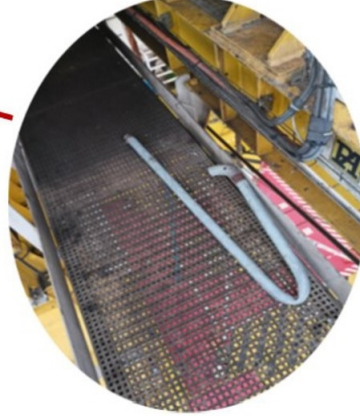
The boom rest landing section on the boom knuckle came into contact with the top gutter walkway guardrails on the pipelay tower. A section of the rail (approx. 1.2 m and 5.5 kg) broke off and fell approximately 22 m to a walkway below.

- There was a lapse in concentration due to distractions during the operation.
- The banksman was primarily focused on the load and its travel path rather than on the crane itself.
- The crane operator's view was obstructed by the knuckle boom.
- The crew were new to the vessel:
 - There was a lack of awareness of possible clash points and were not highlighted in the deck induction.
 - The crew were not familiar with the vessel set-up when working in close proximity to tower.
- There was an unidentified hazard (i.e. deck structure clash points).
- There were no engineering controls to warn the crane operator of close proximity to a structure.

- **Are we out of the line of fire?** Discuss what key controls you have in place to remove yourself and your team members from the potential line of fire.
- Ensure drop zones are identified for any potential clash points when performing lifting operations in close proximity to other structures or equipment.
- Ensure there is a robust and effective barrier management process used to manage all drop zones.
- Ensure all potential crane collision points are identified and included in worksite inductions, toolbox talks and risk assessments.
- Where applicable, ensure additional 'spotters' are used to assist the banksman.
