Hot work performed outside of Permit to Work (PTW) boundary limit

Safety Flash Published on 27 November 2024 Generated on 4 December 2024 IMCA SF 23/24

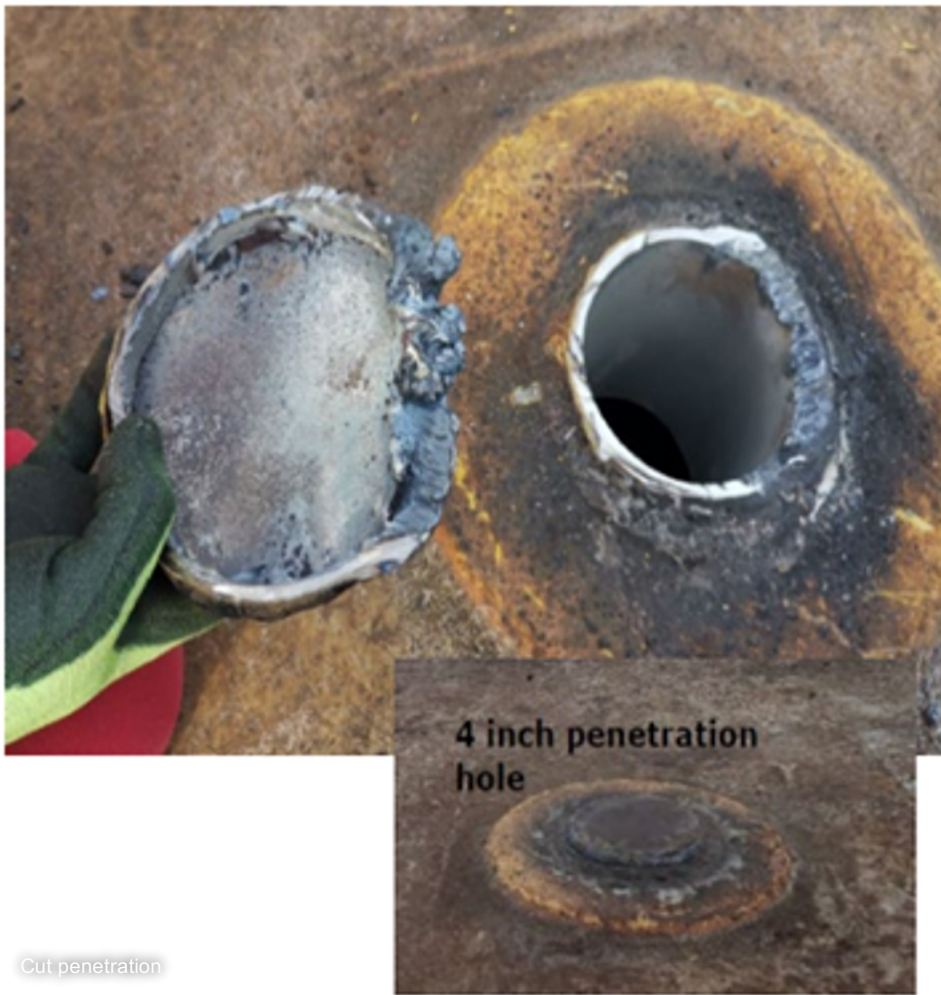
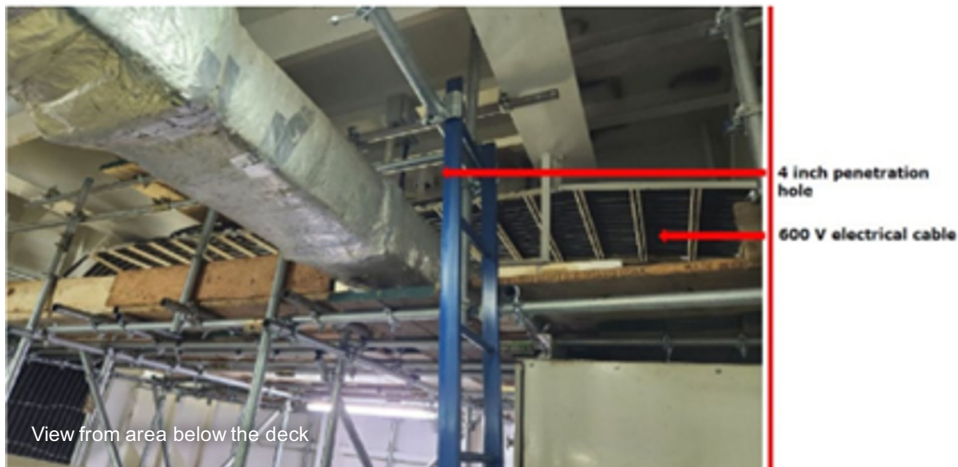
Whilst cutting the 10cm diameter stump, sparks and slag (hot work discharge) dropped into the hole in the deck and fell to a thruster room directly below, onto scaffolding boards and onto a 600V HV electrical cable. There were some burn and scuff marks caused. Vessel engine room crew in the affected area noticed the falling sparks from above, and further identified that there was no fire watcher available in the vicinity. The job was stopped immediately.

- Less than adequate risk perception:
 - The third-party contractor failed to perform an assessment of the affected worksite conditions below the deck and did not understand the working conditions in the surrounding area.
 - No risk assessment was conducted and as a result there were inadequate controls in place.
- Inadequate communication:
 - No proper communication was established during the PTW application (it did not include task being performed).
 - No permission was sought prior to starting hot work on the trip hazard (stump/cover).
 - Assumptions were made that the hot work permit for the welding shop area applied to the surrounding area.

- Inadequate pre-job planning: there was no instruction or operational requirement to remove and cut off the stump on the vessel deck. The foreman decided by himself to cut off the stump as he observed that it posed a trip hazard.
- A pre-job site inspection took place at the welding workshop before the PtW was issued but this not did capture what was going on in the deck below.
- Hot work PtW was applied and obtained specifically for hot work activities inside the welding workshop only.
- There was no supervision from any party at the immediate area when the foreman decided to cut-off the stump/cover.
- There was no fire-fighting safety control provided on the deck below.

- Training:
 - Review and update training material to ensure all aspects of the PTW requirements are captured.
 - Ensure third-party contractors receive adequate training (including refresher training) on the Permit to Work system.
- Job preparation:
 - Review and update pre-job planning, hazard identification, job site inspection and readiness plans before issuing a PTW.
 - Ensure all crew involved are properly informed and updated about any Permits to Work in operation.
 - Review Task Risk Assessment to capture the lessons learned of the incident.
- Ensure adequate supervision available at site;
- **STOP!** remind each other that procedures and processes are there to help us.
