Lost time injury (LTI): Loose grating fell from crane, a man fell through and was injured

Safety Flash Published on 5 October 2017 Generated on 28 January 2026 IMCA SF 24/17

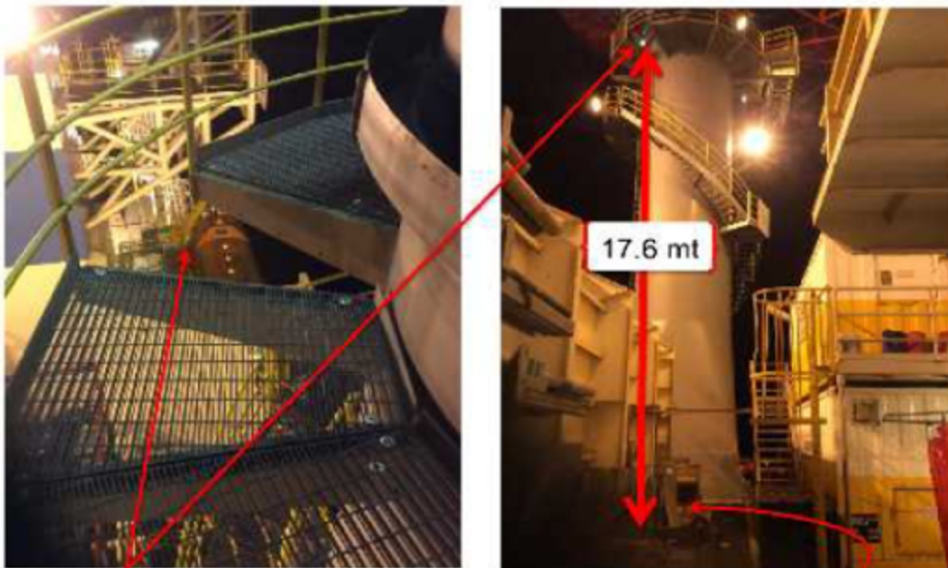
No solid structural support between the support arms. Kick plate is welded to grating and one side of kick plate is against the handrail.

- The grating was loose and fell:
 - The securing clips came loose as a result of the impact of the swinging crane block, and the loose grating was then dislodged.
 - This piece of grating was fixed to the walkway structural frame in only two places.
 - There was a kick plate welded onto the grating and not on the structure as on other cranes.
 - The piece of grating had not been identified as potential dropped object.
- The crane was boomed up above the limit, and the crane operator did not deal properly with this.
- Changes had occurred which were not properly managed or controlled.
- The crane operator inspected the walkway looking at the guardrails, not the grating.

- Safety stand down held with all crew; grating replaced and secured.
- Engineering improvement of walkway design to be made, to prevent recurrence.
- Improvement of training for crane operators and lifting teams, particularly with regard to:
 - emergency procedures
 - handling unusual scenarios
 - management of change (MOC)/risk assessments/toolbox or pre-Job meetings.
