LTI: fall from height during anchor chain handling operation

Safety Flash Published on 17 December 2024 Generated on 20 January 2025 IMCA SF 24/24

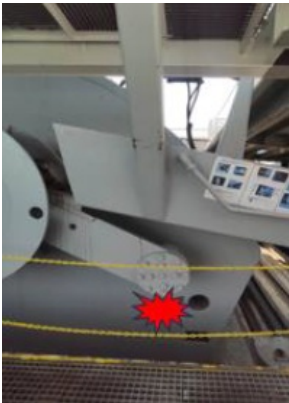
“A” deck – the place from which the bosun fell, illustrating the chain he potentially stepped on

According to the CCTV footage reviewed, the bosun put one foot on the chain barrier while passing the wire over. However, as he attempted to move his second leg, he fell through an opening between two chain barriers and landed 2.75m below on the main deck. First aid was administered onboard, and a vessel doctor called for further assessment. The bosun was subsequently transferred to shore for further medical evaluation. He suffered multiple fractures to his right leg and broke a rib.

- The injured person placed his foot on an unstable surface (the chain barrier), which led to the fall;

- Greater care when accessing locations at height – only correct, proper, secure, stable, and purpose-designed platforms and equipment should be used.
- Better identify potential fall hazards, particularly in areas with open spaces, such as around chain barriers.
- A more thorough and detailed risk assessment should be made for each step of the operation, thoroughly evaluating all associated risks. All identified hazards and corresponding control measures should be clearly communicated to the crew and verified to be in place before starting work.
- Better supervision of high risk tasks, particularly when working at height.

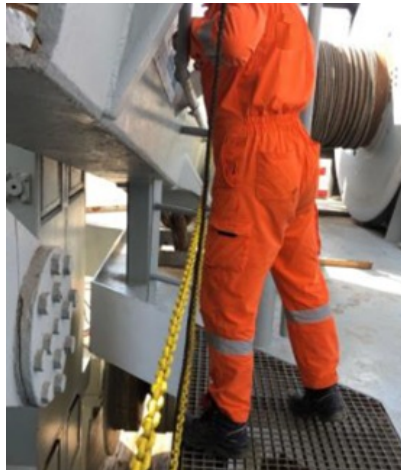
“A” deck – the place from which the bosun fell, illustrating the chain he potentially stepped on
