Structural failure of rescue boat

Safety Flash Published on 17 December 2024 Generated on 20 January 2025 IMCA SF 24/24

A rescue boat suffered a catastrophic structural failure whilst unattended on the davit.

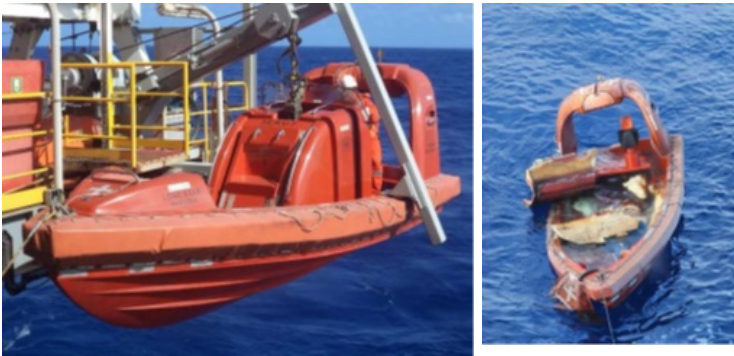
Whilst no activities were being performed by crew on the rescue boat station, the structure of the boat failed causing the lifting frame and the console assembly to be torn off the hull. The hull then dropped into the sea. The remains of the rescue boat were retrieved for further investigation. There were no injuries.

- Forces applied to the fall wire were either equal to or greater than a 1.1 x overload test, as observed on the shock absorber displacement during factory acceptance testing of the boat.
- There were signs that the hydraulic cylinder (shock absorber) was being over-compressed.
- The accumulator of the hydraulic cylinder (shock absorber) was found to be pre-charged with a pressure above that used during the factory acceptance testing of the boat.

Constant excessive force applied to the lifting frame of the boat, eventually led to the lifting frame and the console assembly being torn off the hull. There was constant excessive force applied to the lifting frame of the boat because the shock absorber was unable to absorb the forces caused by excessive manual hand cranking. This happened because:

- The operations manual did not make it clear that it was possible to overload the boat lifting frame by hand cranking the davit.
- The crank lever system available had no means of monitoring or controlling the loads being applied.
- The ongoing damage to the boat and its lifting structure had not been spotted by OEM yearly inspections.
- The shock absorber hydraulic cylinder (shock absorber) was not properly maintained.
- The method of stowing the fast rescue boat not using a cradle but pulling the boat structure against the vertical stoppers increased the likelihood of severe structural damage.

- A technical alert was issued to the fleet and all similar rescue boats were duly inspected.
- The hand crank assembly was replaced by a torque wrench, which permitted some control of the hand cranking forces applied to the rescue boat.
- The stopper on the davit was modified.
- Improved site acceptance and on-site assessment when installing equipment from an OEM, including thorough toolbox meetings between vessel engineers and third-party (OEM) representatives on site.
