Near miss: unplanned deployment of PLET outrigger

Safety Flash Published on 9 November 2018 Generated on 12 January 2025 IMCA SF 25/18

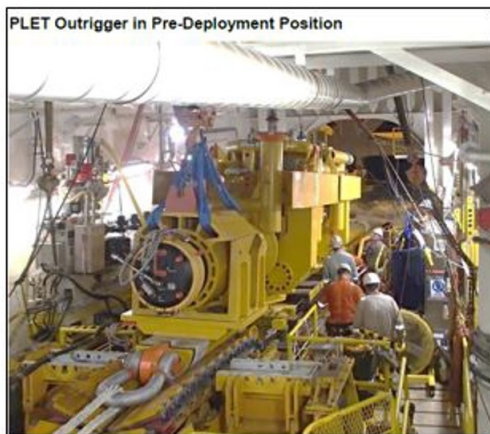
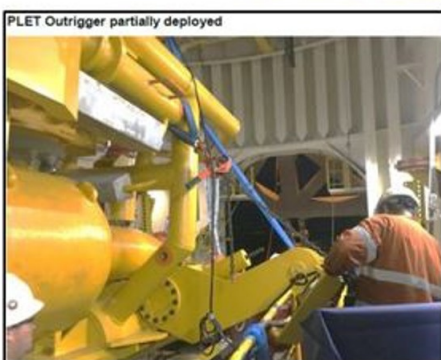
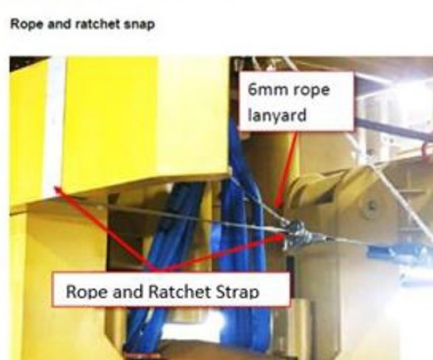
After cutting the ratchet strap, the starboard stabilizer leg deployed to approximately 35 degrees from vertical, coming to rest on the pipeline induction heat (PIH), injection moulded poly propylene (IMPP) unit. The port side outrigger released (approximately 60 degrees from vertical) until it came to rest on a nearby handrail.

- Engineering design: there was no integral mechanical means to lock or hold the outriggers in the vertical position.
- Management of change (MoC): original drawings indicated a wire rope sling arrangement which was later changed to a flat ratchet strap.

- A risk assessment did not identify the potential stored energy hazard posed by the outriggers.
- Communication: a decision was made to introduce 6mm rope to the ratchet strap to allow for easy retrieval subsea with an ROV. This decision was made informally and intermittently conveyed between teams (field engineers and rigging), which introduced a new risk.

- Reviewed risk management process for the design of subsea structures to make the process more robust and to allow the project team to analyse structure designs and address all failure points during the design phase.
- Ensure changes to designs as supplied by a customer are managed robustly with justification documented for any engineered changes in rigging arrangements – a more robust MoC.
- Thorough review of risk management processes, particularly between teams and in the 'interface' between teams; in this case, between the fabrication and project teams.
- Reinforced the importance of clear communication during critical operations, to ensure the message/work scope is delivered in a clear manner and that any risks are fully understood by the crews.
