## Near-miss: Release of trapped pressure after ROV dive

Safety Flash Published on 6 October 2016 Generated on 28 January 2026 IMCA SF 26/16

A Member has reported an incident in which there was an unplanned release of trapped pressure from part of the tooling frame under an ROV.

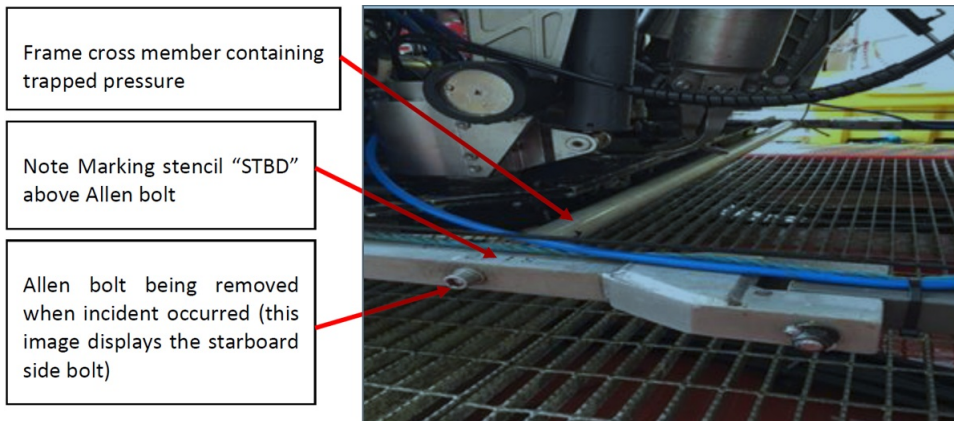
The incident occurred when it was noted that the frame was not deploying correctly and was slightly twisted. Upon investigation the coil mounting frame had been fitted upside down. The crew began to remove the cross member using an Allen key to separate the frame into two sections for removal and to ease the handling during the turning over portion of the task.

Upon the first quarter turn of the port side Allen bolt, a hissing noise was heard. The supervisor immediately evacuated the area and had it barriered off.

- The potential for trapped pressure had not been identified.
- The frame had been incorrectly fitted.

- An engineering solution was identified to prevent possibility of trapped pressure – holes drilled in cross-member.

- Safety flash issued.
- Other similar systems checked and modified as required.
- Clear markings applied to ensure correct frame orientation.
