## High potential dropped object during lifting operations

Safety Flash Published on 3 December 2018 Generated on 23 February 2026 IMCA SF 26/18

A crewman was hit by a steel plate bouncing off the deck after it fell 14 m from a load after a magnet failed.

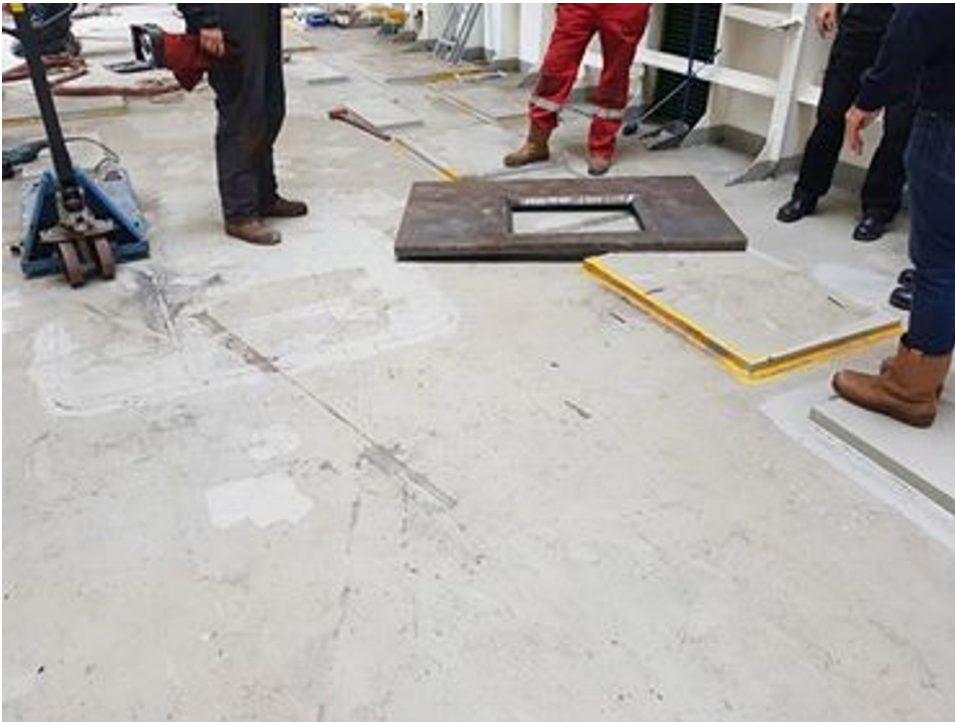
The incident occurred when shaped steel plates for reinforcing were being lifted from the main deck to the ROV hangar through a hatch. The lifting equipment was a 25T crane, two connected soft slings and a heavy-duty magnet. As a lift was swung into position over the hatch opening, one steel plate (sized roughly 1.5m x 1m and weighing approx. 450 kg) came loose from the magnet and fell approximately 14 metres down into the ROV hangar.

A welder foreman who was in the area underneath, was struck by the plate in the back of his legs as the plate bounced up from deck. Investigation after the incident showed the plate had bounced twice and the last time it struck the bulkhead forward in the ROV hangar. The welder was able to walk away from the incident but complained subsequently of pains where the plate had struck. He was sent to hospital for a check-up and returned to work the next day.

- Lifting plans should be followed and should also cover all aspects, as in this case, where there are differences in object properties. This short cut could easily have resulted in major injury and, more than likely, a fatality if the plate had struck directly.
- The importance of following plans and also focus on identifying increased risk cannot be stressed enough.

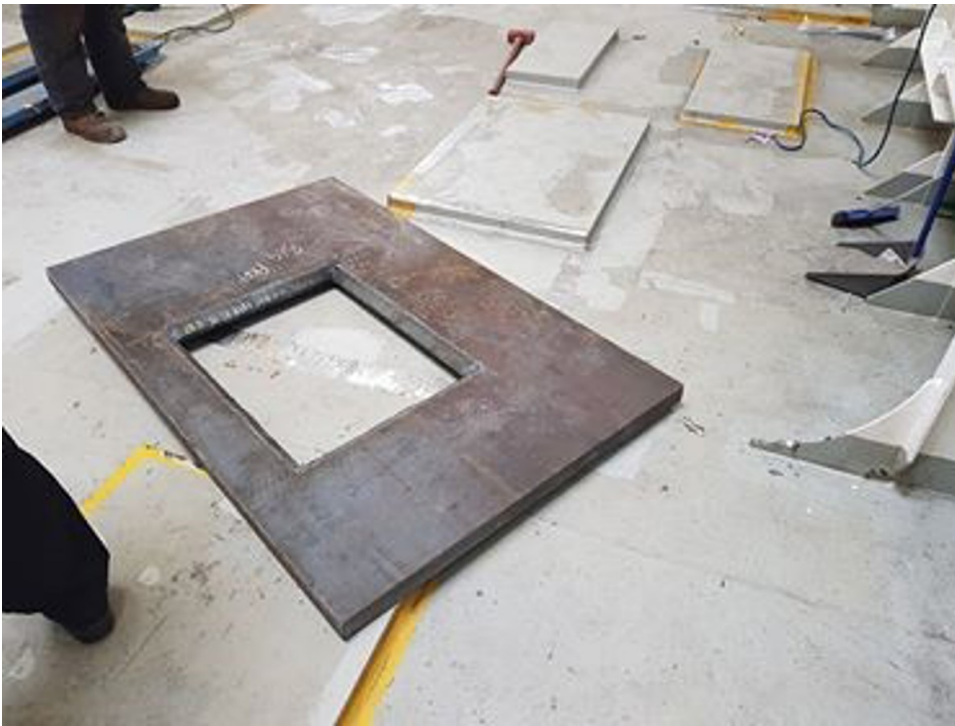
- The plate was so shaped that the magnet could not hold it properly: it was noted that 8 or 9 rectangular plates without cut outs had been lifted successfully with the magnet. The plate that fell was shaped differently, having a rectangle 68 cm x 54 cm cut from it (see photographs). As this plate was to be lifted, no one took into consideration that this plate had a large cut out, limiting the connection area for the magnet.
- Clear instructions were not followed: investigation also shows that the lifting operation was planned with clear instructions **NOT** to use magnet for lifting into ROV hangar. Pallets were to be used to lift plates into hangar, and magnet to distribute only, not above 300mm off deck.
