High potential DROPS near miss: Failed crane component

Safety Flash Published on 4 September 2020 Generated on 14 January 2025 IMCA SF 26/20

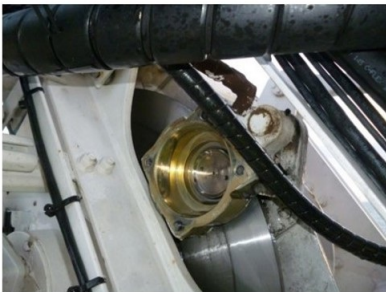
Whilst preparing a crane for operations, the additional man riding calliper brake casing cover on the primary winch failed, causing the brake pad, rings and cover to fall to the deck along with a small discharge of hydraulic oil.

Brake housing showing sheared bolts

Subsequent preliminary investigation by the manufacturer showed that the calliper had been subjected to significant hydraulic overpressure (up to 260 bar, as opposed to 170 bar design).

It is likely that the bolts holding the calliper assembly together failed due to repeated overloading.

- Affected lines were isolated by blanking. allowing safe continued use for general loads, although no man-riding can take place.
- Ensure all pressure-relief valves are correctly adjusted, in order to

prevent further overloading.

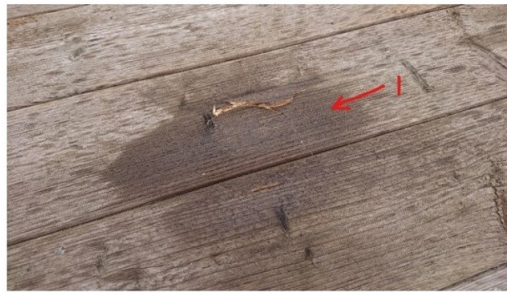
Five items were found on the deck below, these would have dropped from a height of about 25 m. Two of the largest items dented the wooden sheathing to a depth of 1-3 mm. One of these weighed 1100 g, the other, 460 g. The remaining three items left no indents.

Dents in the wooden deck

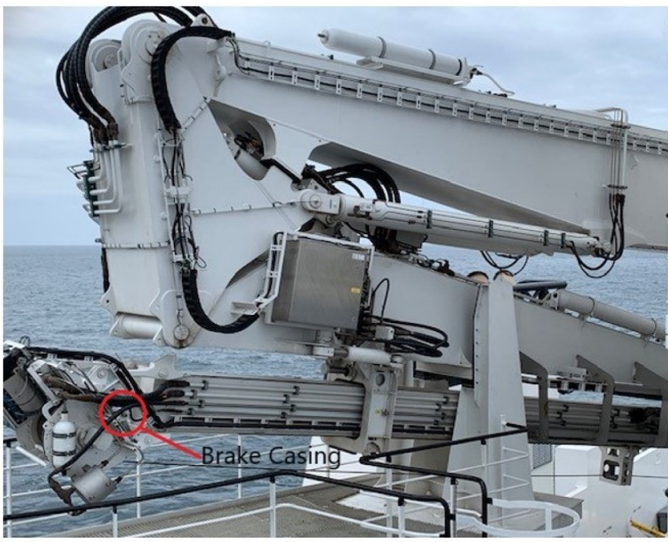
*Location of brake
at head of crane*

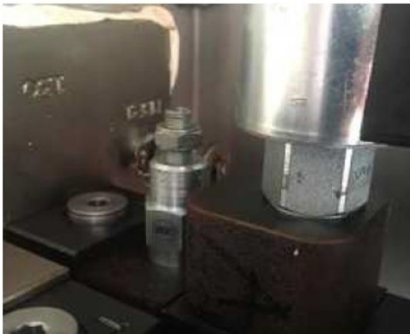
Of the two pressure relief valves fitted to the man-riding brake system, which should have been adjusted during commissioning (the crane had been in service for only six months), one had a loose locking nut, the other was found screwed fully in, suggesting neither had been correctly set.

First valve with slack locking nut

- Immediate – hydraulic pressure relief valves failing to operate.
- Root – Changes made during commissioning were not evaluated thoroughly.

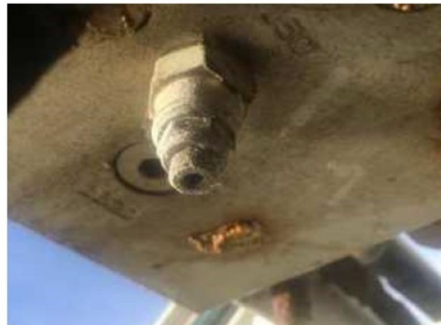
Second valve set incorrectly
