Near miss: Lever hoist failure

Safety Flash Published on 4 September 2020 Generated on 20 January 2025 IMCA SF 26/20

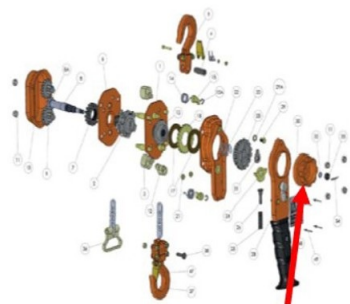
Figure 1 showing worn part

- On investigation and inspection, worn cog teeth were found. A toothed part of the gear assembly (see figure 1) was found to have excessive wear.
- This gear assembly was not visible without stripping the unit, so wear would not have been evident during pre-use checks. Strip down of a working unit would invalidate the manufacturer's warranty and certification.
- Our member noted that a thorough examination cannot be conducted *in situ* and units must be taken to a workshop for full examination.

- Reviewed and amended the process for recertification of rigging with moving / wearing parts.

- Arranged for supply of newly certified rigging lofts on a 6-monthly basis.
- Revised internal documentation on lifting operations appropriately.

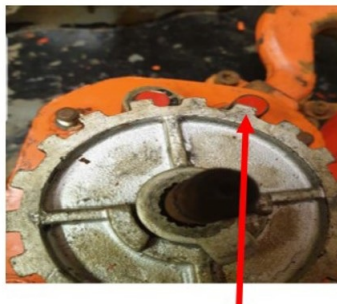
Worn cog teeth found
