Vessel collision with underwater objects in harbour

Safety Flash Published on 23 November 2022 Generated on 28 January 2026 IMCA SF 26/22

A vessel suffered underwater damage to the hull when it collided with uncharted objects in the harbour.

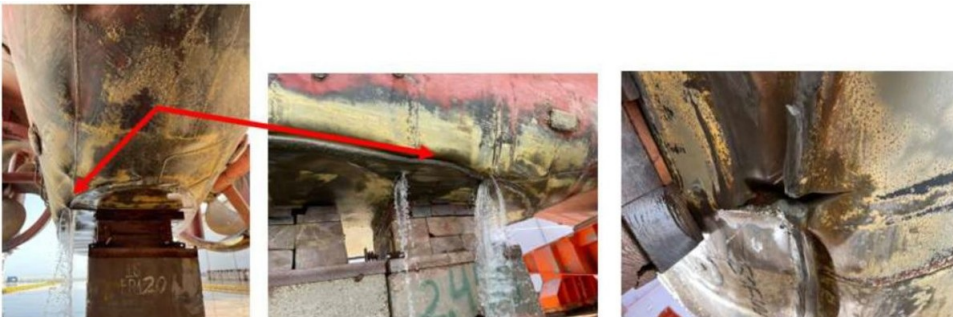
The incident occurred after completion of cargo operations when an AHTS vessel cast off from the quayside for departure. While proceeding towards the harbour channel and leaving the mooring buoys on its port side, crew on the vessel felt a blow to the vessel. Immediately the crew went to check for damage and found out the vessel was holed – seawater was coming in. The authorities were informed and the vessel returned to the quayside. The vessel had to be dry-docked for repairs.

The vessel collided with uncharted underwater harbour pilings.

- There were no proper navigational markings – the piles were not marked with floating buoys.
- The most recently updated charts for the harbour, provided by the authorities six months before this incident, did not reflect the exact co-ordinates of the underwater piles.
- The pile height and the water depth information provided on the chart did not match the “under keel clearance” calculation done by the bridge crew on the vessel.

general coordinates for an area in the harbour without any coordinates identifying the underwater piles. The notice did warn all vessels to be “careful in this area” but did not restrict entry to it.

- Comparison of the coordinates where the collision took place, with underwater pile coordinates subsequently obtained by the company, confirmed absolutely that the vessel hit one of the piles.

- Bridge crew should calculate “under keel clearance” considering draft versus water depth, height of subsea objects, vessel stability, weather conditions and squat effects when navigating through a potentially hazardous area.
- If possible, avoid navigating through areas for which notices to mariners or similar warnings are in place. If there is no option but to do so, it may be appropriate to seek shore-side management approval.
