High potential near miss: Dropped Paraguard stretcher during drill

Safety Flash Published on 13 November 2023 Generated on 23 January 2025 IMCA SF 26/23

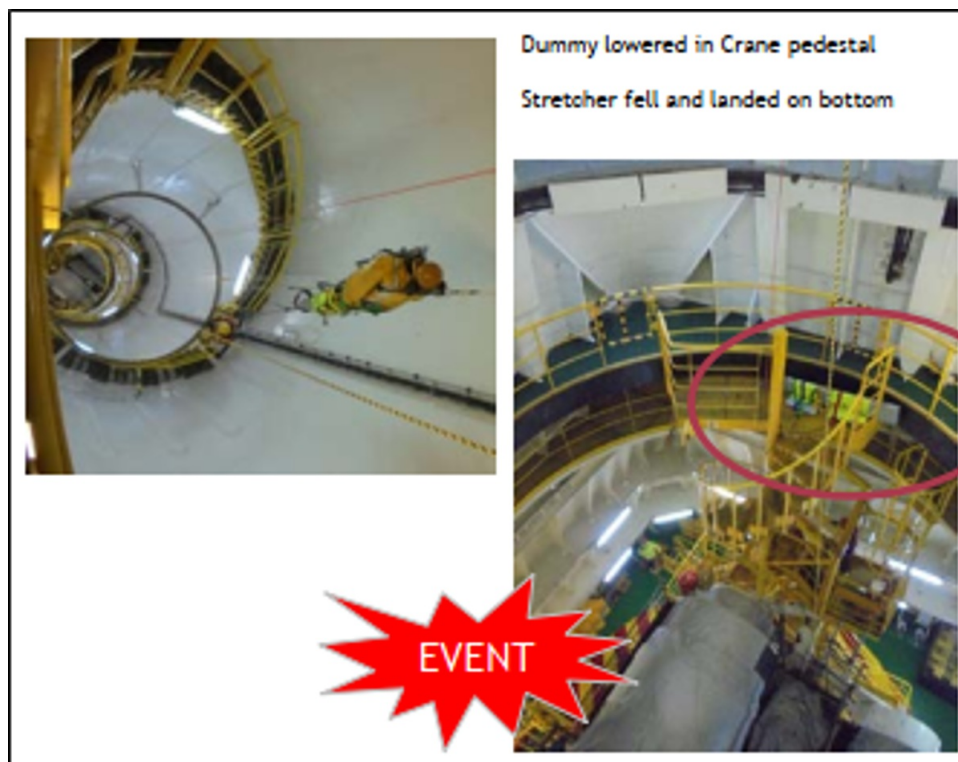
For the first transfer through the top hatch, using the tripod, the lifting point on the stretcher itself was correctly used. However, after the transfer to the descending davit, the descending cable was attached to the Dummy harness, *not* to the stretcher lifting point.

This led to the stretcher and dummy not being secured to each other, and the stretcher slipping during the descent.

During a rescue from height /evacuation drill within the top of the main crane pedestal, a Paraguard stretcher (12 kg) slipped out from the dummy and fell approx. 50 m to the crane winch room below

- The rescue plan was too generic and did not address specifically the process by which the injured person in a stretcher would be lowered.
- Despite the presence of several rescue team members, nobody noticed that the rope was connected to the wrong attachment point.

- Rescue teams ought to be familiar with the stretchers used on board, and follow the manufacturer's instructions.
- Rescue plans should be specific and contain detailed information related to the equipment used (Stretcher, Tripod, Davit) and the descent/lowering process, load transfers and connections. The Plan should be reviewed at the toolbox talk before the drill, and this should include as much as possible hands-on practice with the specific stretcher.

- The Potential DROPS area below the area where the drill is occurring should be barricaded, marked, and vacated during the descent. Special attention may be required to ensure that the medical team stood by, are kept outside of the potential line of fire.

- Review the rescue plan in this case to
 - Ensure that suitable rescue equipment is used (if space is limited, the use of a stretcher can pose additional hazards and use of a harness may be an acceptable alternative);

- Incorporate more specific details on the process of lowering the casualty.
