High potential near miss: Guide cone funnel dropped

Safety Flash Published on 22 November 2019 Generated on 17 January 2025 IMCA SF 27/19

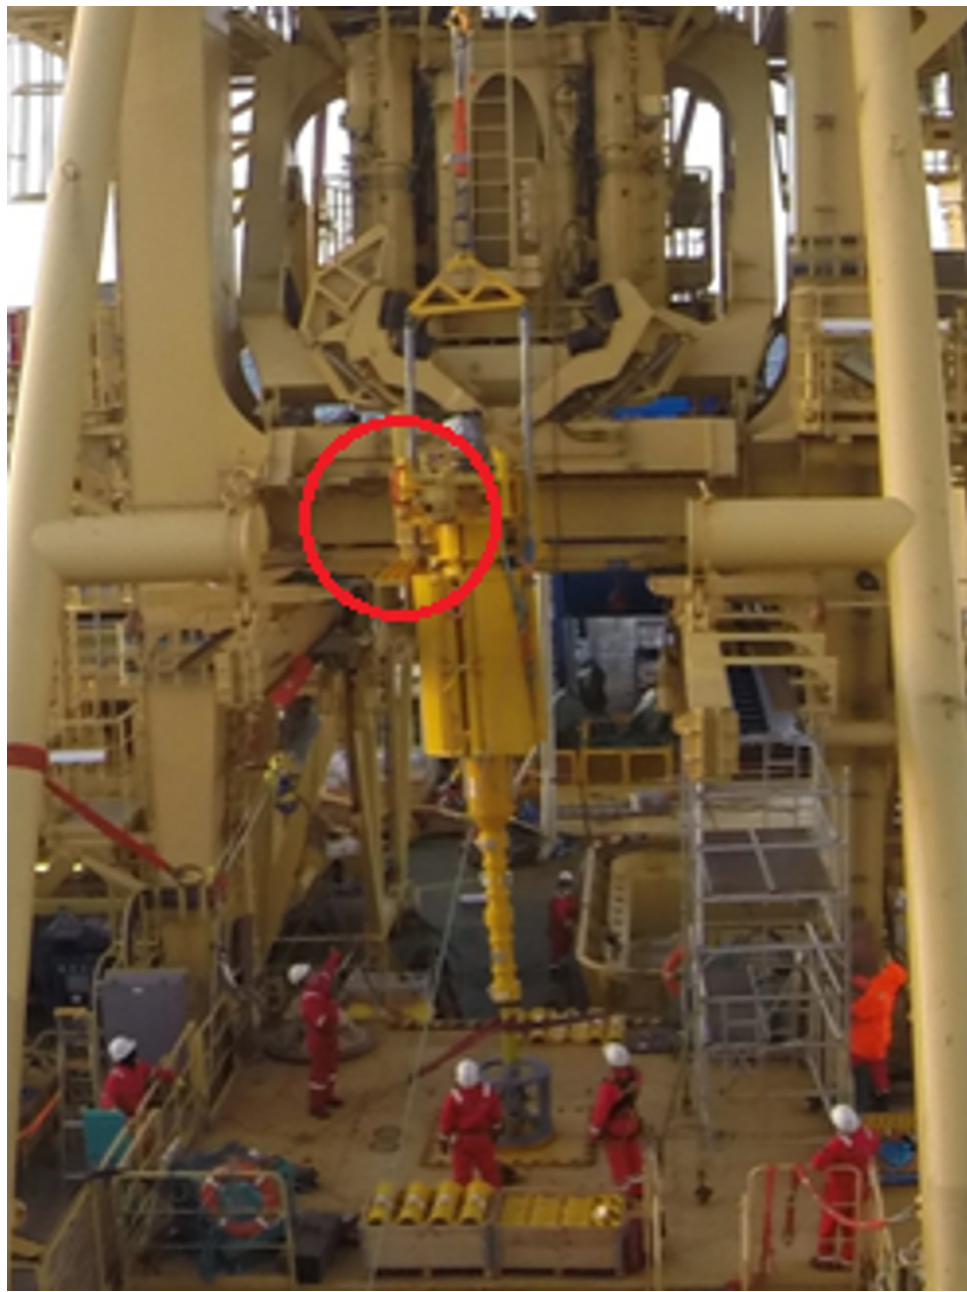
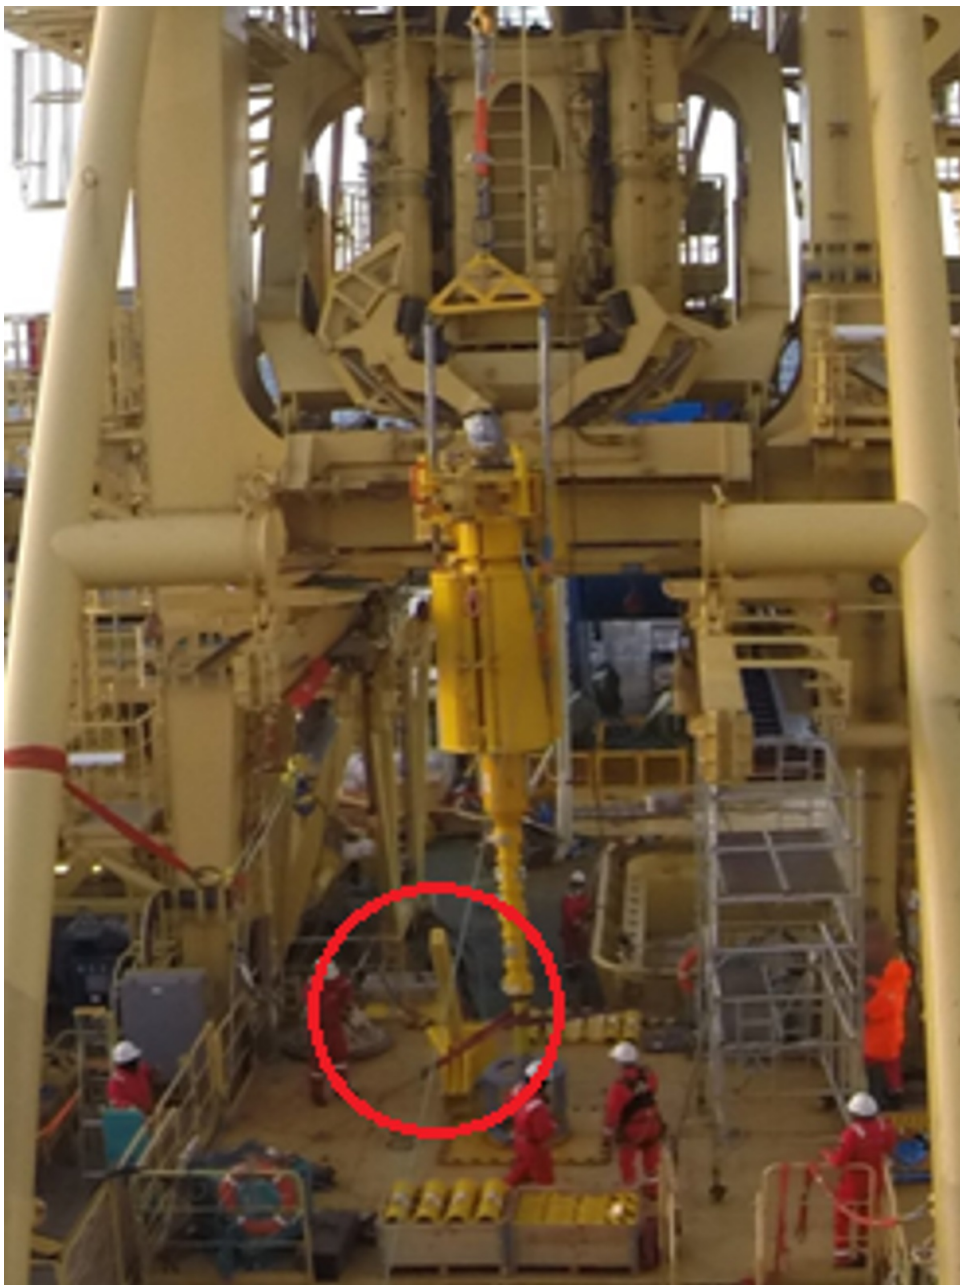
An umbilical termination head (UTH) guide cone funnel fell from its sleeve connected to the UTH body.

The UTH was the 2nd end of the umbilical. It had been lifted over the vertical lay system (VLS) tower and was being prepared for deployment when the incident occurred. The UTH guide cone funnel weighed approx. 500 kg and fell more than 4 m towards the moonpool doors.

The next step prior to deployment was to fit the bend restrictors under the UTH. While lifting the UTH from the hang-off collar to fit bend restrictors, the guide cone funnel fell off.

- The guide funnel locking mechanism failed to secure the guide funnel in vertical orientation, due to too small locking protrusion.

- **Design:**
 - the locking mechanism on guide funnel was not suitable for the vertical orientation. The locking mechanism was secured with a cable tie, and there was no designed-in secondary securing for the locking mechanism or the guide funnel
 - the outboard connection c/w guide funnel was an existing design used for installation in horizontal orientation
 - supplier design review may not have covered change in use in a proper

way. This is being investigated by the supplier

- Risk assessment and/or design review or re-assessment highlighting using an existing design in a new way.
- All guide funnels from this supplier with this design should be modified with a secondary securing/locking mechanism designed to withstand installation forces.
- Revision of umbilical termination head manual to further highlight risk factors (e.g. loose items and locking system etc).
- All parties involved in engineering, fabrication and installation should be included in design reviews, HAZOP, HAZIDs etc.
