Main ROV lift wire umbilical and bullet parted

Safety Flash Published on 22 November 2019 Generated on 28 January 2026 IMCA SF 27/19

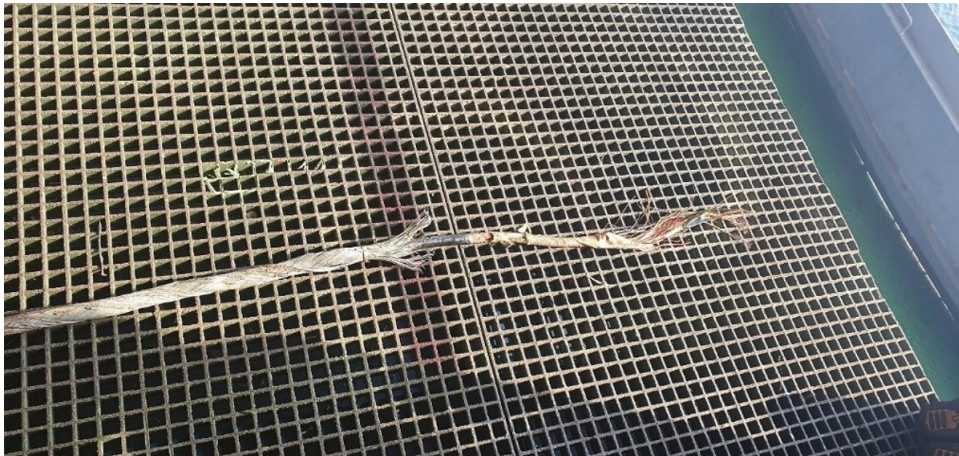
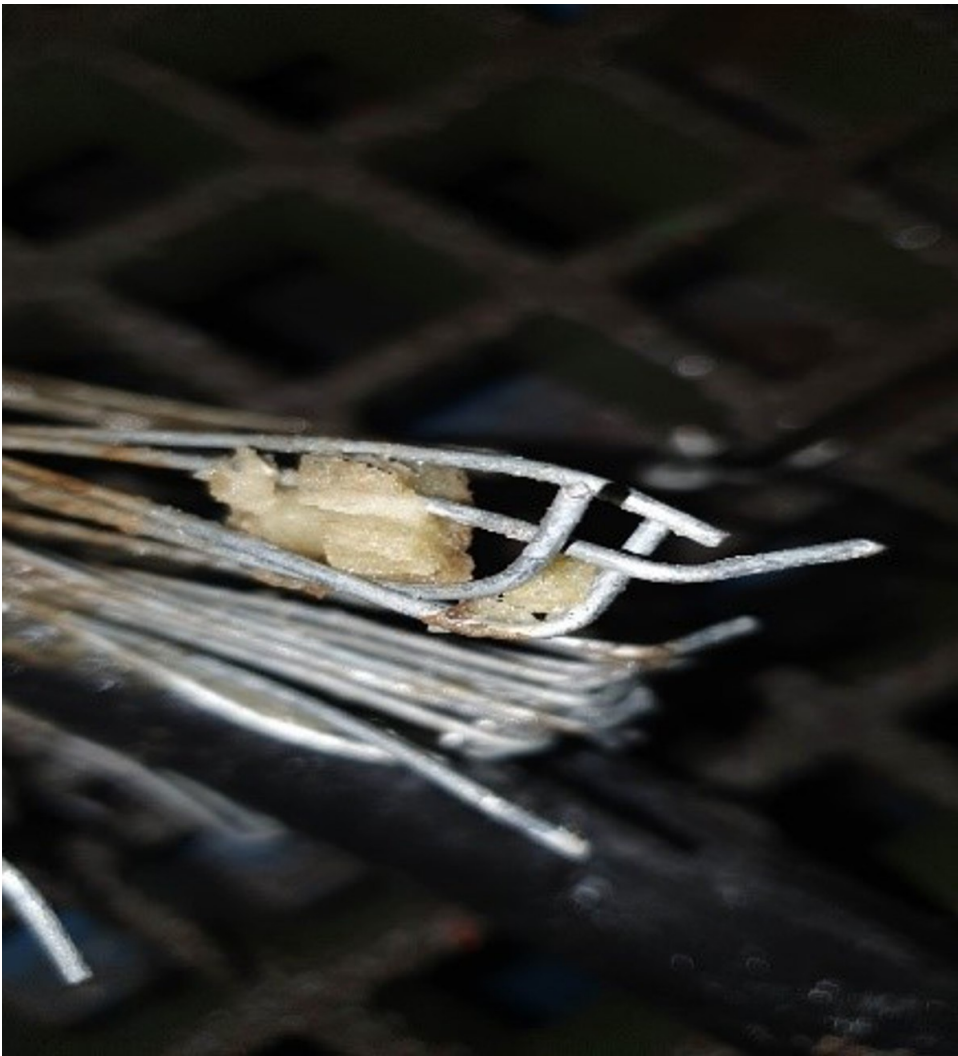
- The TMS main lift wire and bullet parted. Further inspection identified a failure in the armour wire shield which was found to be dry with no signs of grease or any oil contamination.
- It was noted that the Wirelock® potting compound inside the socket was scattered into small pieces. The armour wire end bends appeared to be existing and no deformation noticed. Exposed armour wire length was 89 cm.

- The evidence presented post-incident indicated a failure of the system main lift umbilical at the connecting bullet termination point which was secured via a chemical potting compound (Wirelock®).
- The main lift umbilical connection to the TMS had been recently re-terminated. A review of the procedures and certification test records for this work confirmed that:
 - procedures in line with the manufacturer's instructions were followed by certified competent personnel
 - the Wirelock® used was within use-by date

- The technician who conducted the re-termination commented that the volume of product used was approximately 30% less than he had anticipated, and the compound did appear to be slightly more glutinous or viscous than usual.

- This is believed to be due to higher than normal ambient temperatures.
 - The inspection team did consider this to be a factor regarding exposed surface area of the main lift umbilical wire mantel within the bullet, however, the connection did successfully pass an overload test on completion.

- The **immediate cause** of the parting of the main lift umbilical from the TMS connection bullet, was seen to be failure to follow correct procedures.
- The **root causes** were:
 - failure of the potting compound inside the TMS bullet
 - failure to take into account high ambient temperatures when working with the potting compound.

- Amend procedure for potting sockets whilst in high temperature environment and where possible conduct work only within set temperature guidelines given by manufacturers.

- Consider alternative supplier for better temperature range product.
- Changes in procedures to indicate:
 - temperature of environment in which work is conducted
 - volume by weight or volume of compound used
 - compound batch number and storage details.
