## MAIB: Crush fatality during lifting operations

Safety Flash Published on 1 October 2021 Generated on 24 January 2025 IMCA SF 27/21

The UK Marine Accident Investigation Branch (MAIB) has published [Report 12/2021](#) into a fatal crush accident which occurred while a gantry crane was moving a hatch cover, on board the general cargo vessel Cimbris, at Antwerp, Belgium, on 14 July 2020.

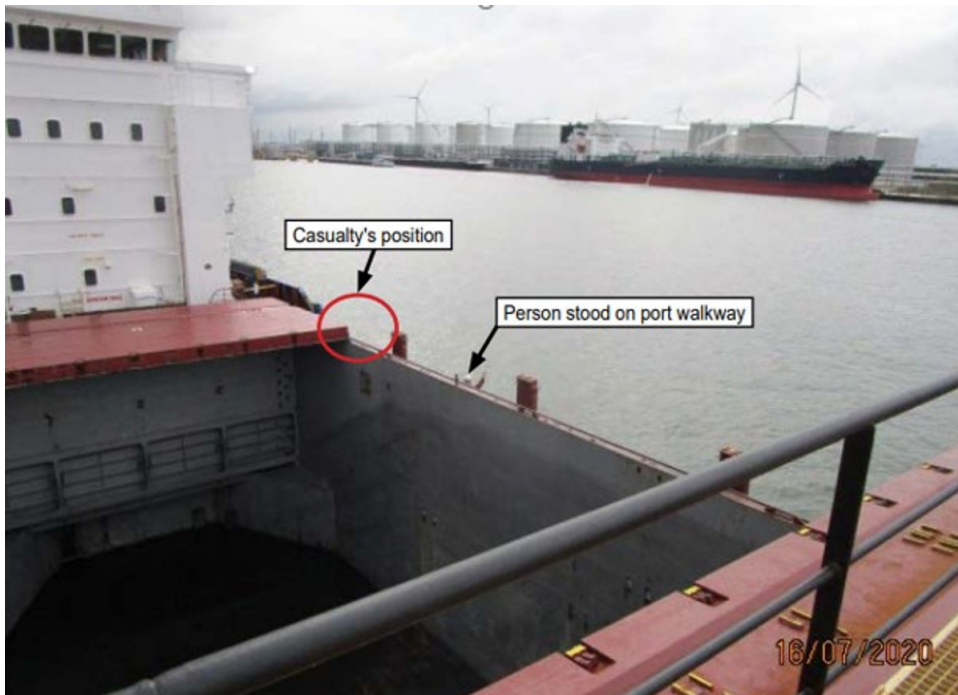
A crew member was fatally crushed when he became trapped between the vessel's gantry crane and a cargo hatch cover.

No one saw the crew member position himself between the moving gantry crane and the hatch cover, but his likely intent was to assess the progress being made by his team working in the hold.

- The crew member was fatally crushed between the gantry crane and the hatch cover because he placed himself in the path of the moving crane and the crane did not stop.
- The crew member almost certainly knew the gantry crane was moving but was probably confident that he could achieve his objective and move out of its path.

- The ship's gantry crane operator did not stop the crane because he did not know the crew member was in the way.

- The Chief Officer did not have a full view of the crane's path from his control position.
- Contrary to the vessel's documented procedures, a second crew member was not used to act as a lookout or banksman.
- The hatch cover lifting operation was not properly planned, adequately supervised, or executed in a safe manner.
- Communication between the ship's crew and port crew was poor and the safety culture demonstrated by both was weak.

- Made it mandatory that there be a second person to act as safety sentry during the operation of cranes, gantry cranes or hatch cover machinery.
- Reviewed its safety procedures for such operations.
- Issued a safety instruction card, defining the role of safety lookout for all crane operations.
