Serious finger injury during valve installation

Safety Flash Published on 18 October 2016 Generated on 28 January 2026 IMCA SF 28/16

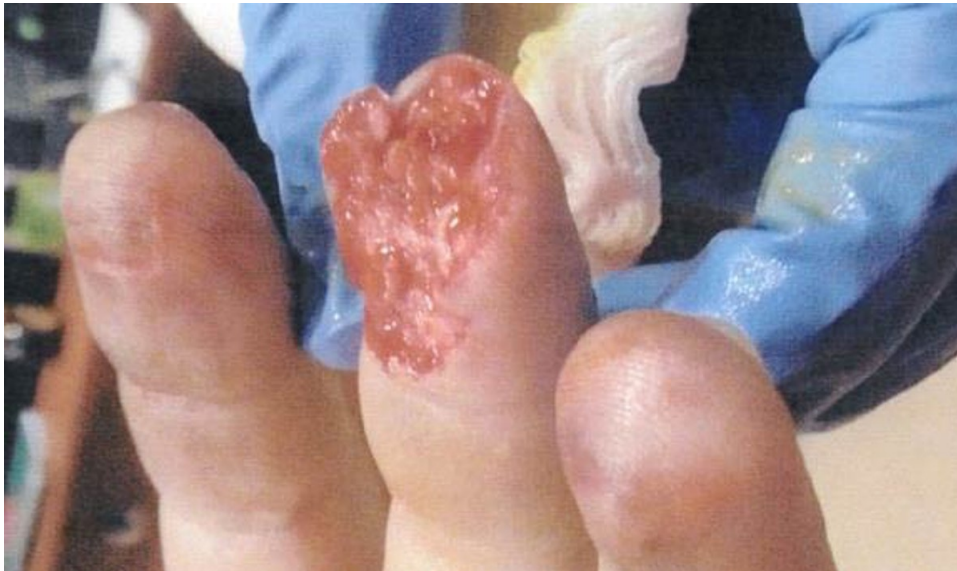
The incident occurred during valve operation function tests on a remotely operated pneumatic controlled valve for a vessel fuel system. There were some issues with the opening and closing of one particular valve. The decision was taken to change out the valve.

The second engineer used an air-gun to supply low pressure compressed air to the valve, instead of reconnecting the valve to the system air controlling pneumatic valves. During this pre mounting test, the valve did not open properly and got stuck in a half-open position. The engineer tried to move the valve-flap with his fingers. At the same time, he supplied air to the actuator with the air-gun. The valve-flap suddenly closed, and the tip of his left middle finger was cut off by the valve-flap. The engineer was medevacked.

- The immediate cause of the incident was the engineer using his fingers directly on the valve-flap instead of using the correct tools.
- The job was considered routine by the engine crew.
- The valve was not secured whilst the engineer tested it.
- There was no rush when it came to replacing the valve; the crew could have used sufficient time to plan the operation in more detail and agree upon which equipment should be used.
- The engineer carried out simultaneous tasks – he was holding the air-gun with one hand, the valve with the left hand and simultaneously tried to move the valve-flap with his fingers, taking a shortcut.

- - inadequate or substandard planning
 - the use of short-cuts
 - Some of the causal factors were as follows
 - Poor or inadequate risk assessment: the engineer should have been aware that the valve-flap could suddenly close, and have prepared for it

- Further review of company's Permit to Work procedures, Lock Out Tag Out System procedures, and Risk Assessment procedures.
- A renewed focus to be on finger/hand injuries.
- Further review of risk assessment for work on fuel system and changing of pneumatic valves.
