## Serious finger injury during valve installation

Safety Flash Published on 18 October 2016 Generated on 16 January 2025 IMCA SF 28/16

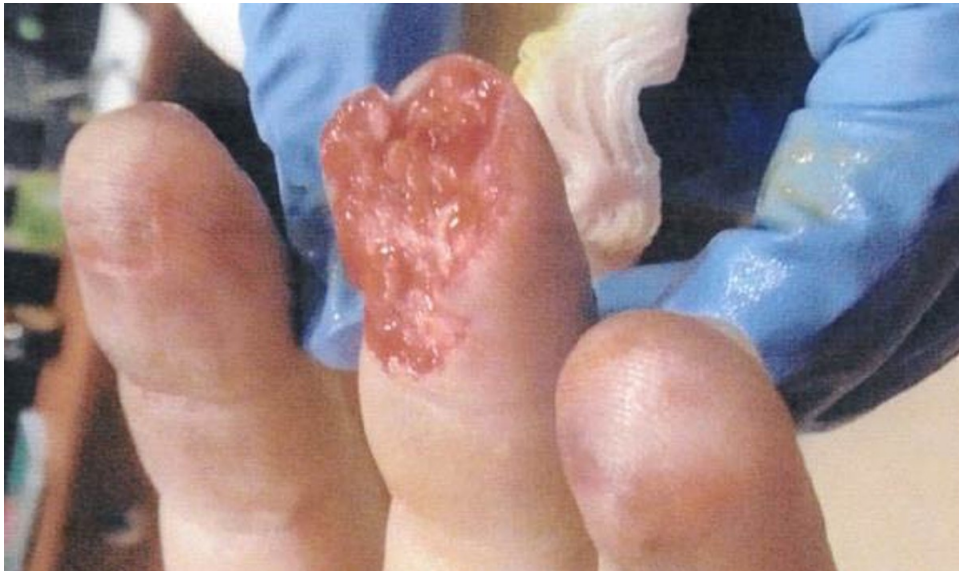
The incident occurred during valve operation function tests on a remotely operated pneumatic controlled valve for a vessel fuel system. There were some issues with the opening and closing of one particular valve. The decision was taken to change out the valve.

A second engineer and the motorman wanted to test the new valve before it was mounted. The actuator and valve were on the engine room deck, and the air supply to the system was disconnected, but cables for remote control of the actuator were connected.

The second engineer used an air-gun to supply low pressure compressed air to the valve, instead of reconnecting the valve to the system air controlling pneumatic valves. During this pre mounting test, the valve did not open properly and got stuck in a half-open position. The engineer tried to move the valve-flap with his fingers. At the same time, he supplied air to the actuator with the air-gun. The valve-flap suddenly closed, and the tip of his left middle finger was cut off by the valve-flap. The engineer was medevacked.

- The immediate cause of the incident was the engineer using his fingers directly on the valve-flap instead of using the correct tools.
- The job was considered routine by the engine crew.
- The valve was not secured whilst the engineer tested it.
- There was no rush when it came to replacing the valve; the crew could have used sufficient time to plan the operation in more detail and agree upon which equipment should be used.
- The engineer carried out simultaneous tasks – he was holding the air-gun with one hand, the valve with the left hand and simultaneously tried to move the valve-flap with his fingers, taking a shortcut.

- Further review of company's Permit to Work procedures, Lock Out Tag Out System procedures, and Risk Assessment procedures.
- A renewed focus to be on finger/hand injuries.
- Further review of risk assessment for work on fuel system and changing of pneumatic valves.
