High potential incident – Man injured while falling overboard (MOB)

Safety Flash Published on 6 December 2019 Generated on 18 February 2026 IMCA SF 28/19

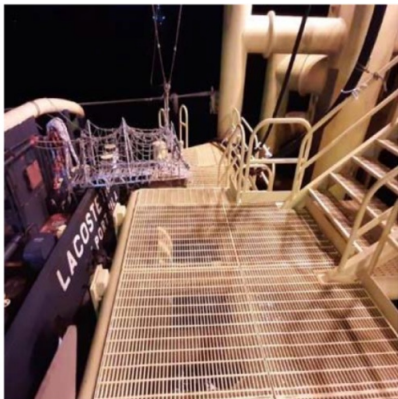
Whilst descending stairs to a boat-landing area on an offshore platform, a sub-contracted employee of one of our Members tripped on a 2-inch discharge hose that had been laid across the base of a stairway.

Position of temporary hoses at incident scene

- The incident was the result of poor/inadequate hose management practices; Hoses were laid across the platform boat-landing causing a trip hazard.
- Control measures as per the approved risk assessment were not implemented;

specifically, the requirement to route hoses in a safe manner. This resulted in poor worksite preparation and insufficient inspection.

- Poor custom and practice – laying hoses on platform walkways had been common practice during the current campaign; they had been temporarily set up four days prior to incident and they were not identified or highlighted as causing a trip hazard.
- Failure to recognise and report hazards – individuals involved in the operations at the time of the incident had previously accessed the platform's boat landing and had failed to recognise and report the hazards presented from hoses laid across walkways.

- Ensure all work tasks are adequately planned and risk assessed before starting work activities, including review of access, egress and escape routes.
- Where temporary hoses are placed at access ways/work areas always, consider additional controls to eliminate the possibility for trip hazards, such as use of cable racks or hose covers.
- Increase focus on critical safety behaviours such as 'eyes on path' when accessing unfamiliar worksites. When hazards and/or unsafe conditions are observed, intervene and report.
