High potential incident – Man injured while falling overboard (MOB)

Safety Flash Published on 6 December 2019 Generated on 17 January 2025 IMCA SF 28/19

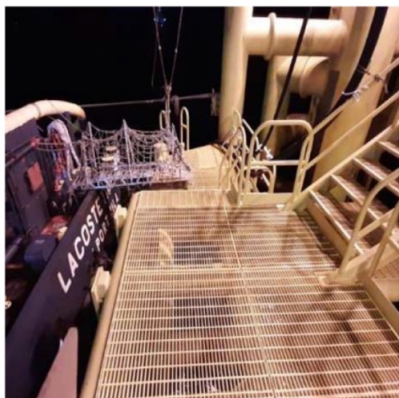
Whilst descending stairs to a boat-landing area on an offshore platform, a sub-contracted employee of one of our Members tripped on a 2-inch discharge hose that had been laid across the base of a stairway.

Position of temporary hoses at incident scene

- The incident was the result of poor/inadequate hose management practices; Hoses were laid across the platform boat-landing causing a trip hazard.
- Control measures as per the approved risk assessment were not implemented;

specifically, the requirement to route hoses in a safe manner. This resulted in poor worksite preparation and insufficient inspection.

- Poor custom and practice – laying hoses on platform walkways had been common practice during the current campaign; they had been temporarily set up four days prior to incident and they were not identified or highlighted as causing a trip hazard.
- Failure to recognise and report hazards – individuals involved in the operations at the time of the incident had previously accessed the platform's boat landing and had failed to recognise and report the hazards presented from hoses laid across walkways.

- Ensure all work tasks are adequately planned and risk assessed before starting work activities, including review of access, egress and escape routes.
- Where temporary hoses are placed at access ways/work areas always, consider additional controls to eliminate the possibility for trip hazards, such as use of cable racks or hose covers.
- Increase focus on critical safety behaviours such as 'eyes on path' when accessing unfamiliar worksites. When hazards and/or unsafe conditions are observed, intervene and report.

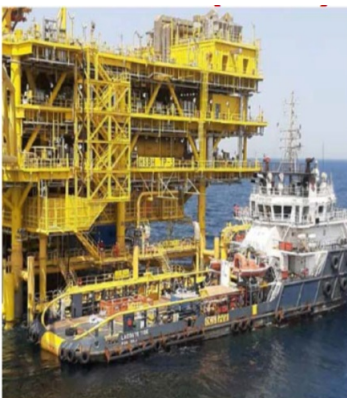
Reinstated work area, free of trip hazards - post incident event
