## LTI: Fingers injured during fender lifting operation

Safety Flash Published on 6 December 2023 Generated on 22 January 2025 IMCA SF 28/23

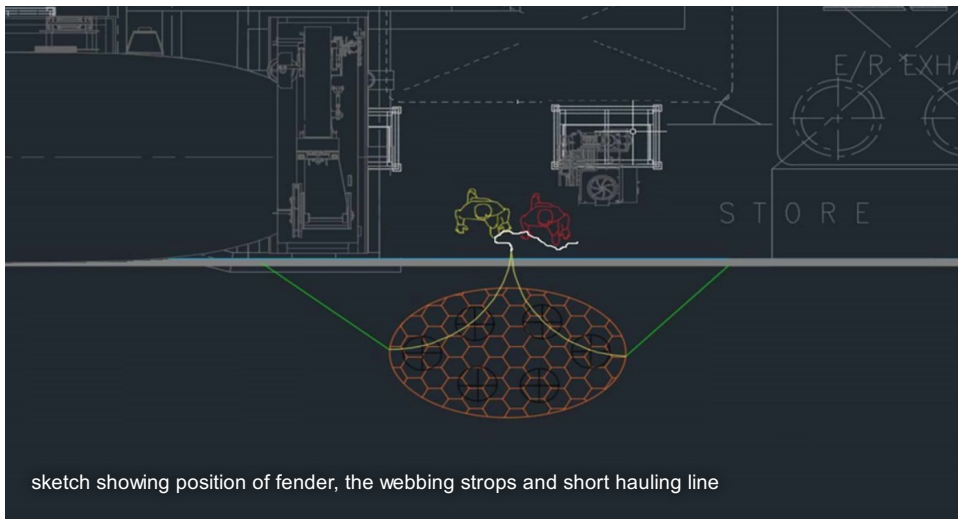
The injuries occurred while hauling up the webbing slings with a (13mm (half-inch) polypropylene rope so that a Yokohama fender, weighing approx. 415 kg, could be lifted to deck.

During this activity the swell caused the rope he was holding to slacken and then come under tension suddenly, and the rope jerked violently and was pulled out of his hand.

sketch showing position of fender, the webbing straps and short hauling line

- PPE cannot always be relied on to prevent injury and is a last line of defence. In this case, our member considers that impact-resistant gloves should have been worn because of the risk of pinch points and entrapment injuries.
- The rope that was tied to the handrail did not have sufficient slack to allow the rope to be easily untied, the snatching could have been avoided either by having extra slack in the rope, or by cutting it.

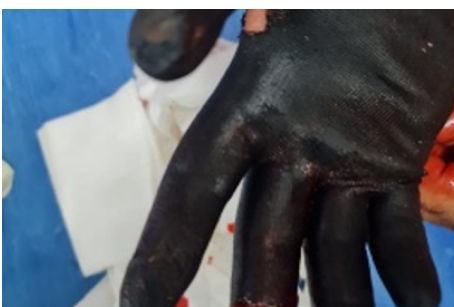
Glove prior to removal. Damage to thumb area was pre-existing

- Although the PPE was inadequate to prevent the injury, substitution with Impact Resistant Gloves, or any other available glove options for this activity, would have been unlikely to have prevented it. The injury was to the palm side of the glove which is not an area where armour or thick padding is traditionally found.
- Watch out for complacency and “task seen as routine”.
- Ensure everyone involved, supervisors and workers, feels empowered to stop the job when conditions change and/or become unsafe.

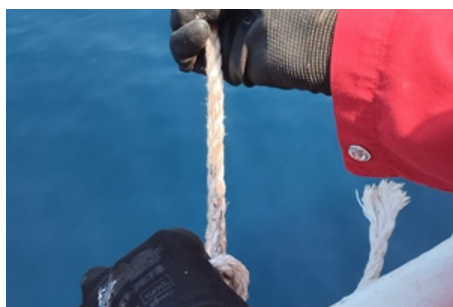
Final hand position (re-enactment).

- The fender surged a great deal with the swell, this caused the line to jerk in an uncontrolled manner, the rope line jerked out of the workers hand and this was enough to cause the injuries.
- There was a lack of risk perception, the task was seen as routine.
- STOP WORK Authority not used.
- The rope was handled from underneath so that the direction of energy was through the hand (rather than from above which would make release of the rope automatic); this may have contributed to the severity of the injury.
