Failed shackle on vessel life raft

Safety Flash Published on 17 December 2019 Generated on 20 January 2025 IMCA SF 30/19

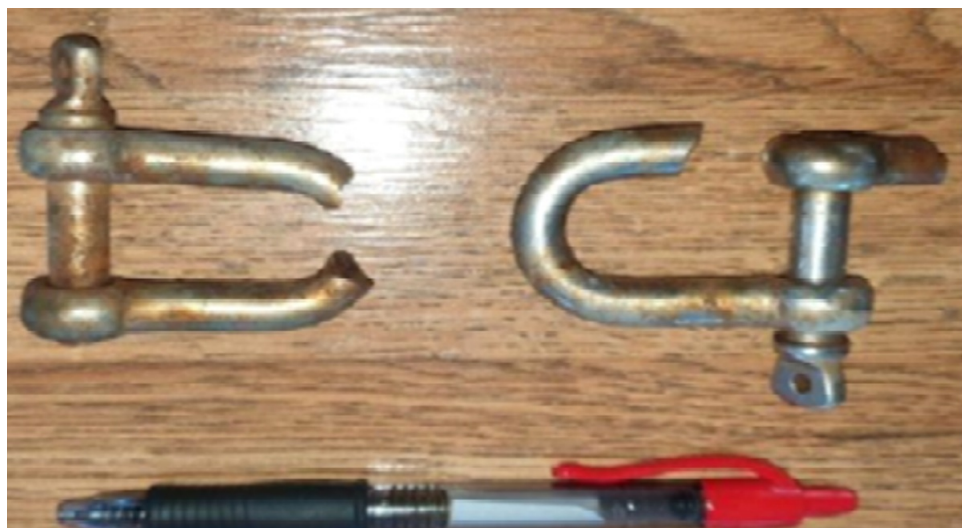
There was a failure of two stainless steel “D” shackles forming part of a life raft hydrostatic release assembly on a vessel.

The failed/parted shackles released the strap securing the life raft container to its stand.

As a result, the life raft container fell into the water but remained connected to the vessel via the painter.

The shackles potentially failed due to crevice corrosion over time.

- Appropriate authorities were informed, and arrangements were made to replace the inflated life raft.
- All remaining life raft stainless steel shackles were replaced.
- Inspections were carried out to identify vessel equipment with potential for crevice corrosion and galvanic corrosion.
- Weekly checks to be carried out on the condition of shackles during weekly life raft inspection.
- The preventive maintenance schedule was improved to ensure the timely replacement of such stainless steel shackles before they fail.
