## Improper use of heaving line

Safety Flash Published on 17 December 2019 Generated on 20 January 2025 IMCA SF 30/19

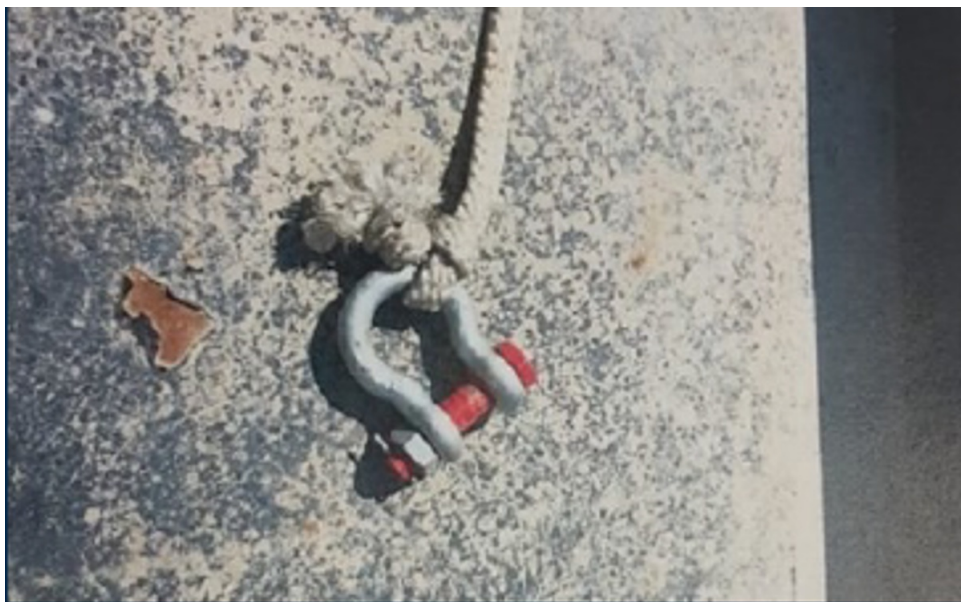
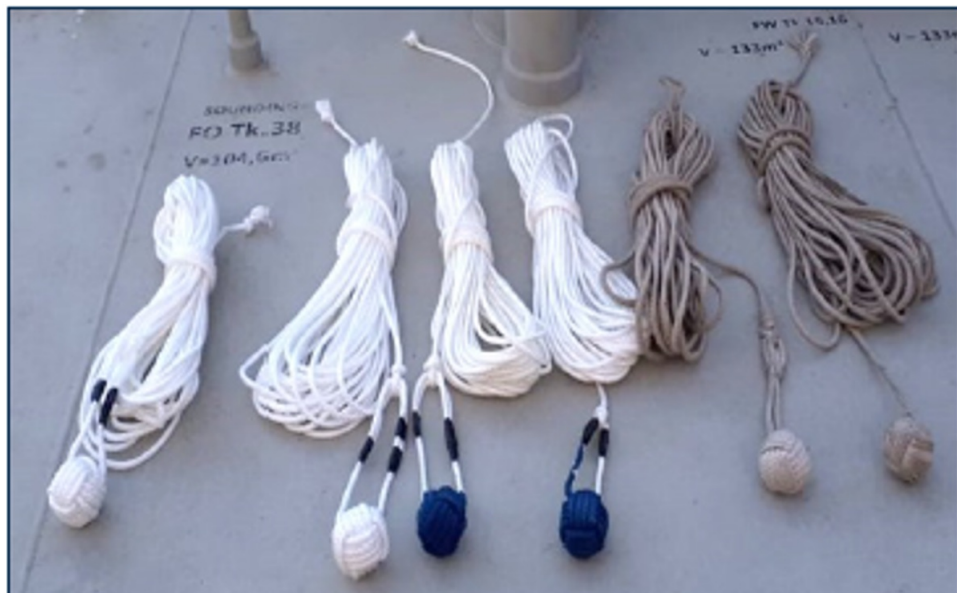
During a mooring operation, vessel crew were found to be using a 4-ton shackle attached to a heaving line (instead of proper “monkey fist”).

The crew did not have an available heaving line with a “monkey fist”.

- Risk assessment for mooring operations to be reviewed.
- A check to be included to ensure that a sufficient number of heaving lines with “monkey fist” are available.
  - In this case, at least 9 heaving lines were to be kept on the vessel (2 for use at each mooring station plus 1 spare).
