Shackle failure during over-boarding of pennant wire and ballast chain

Safety Flash Published on 18 November 2021 Generated on 23 January 2025 IMCA SF 31/21

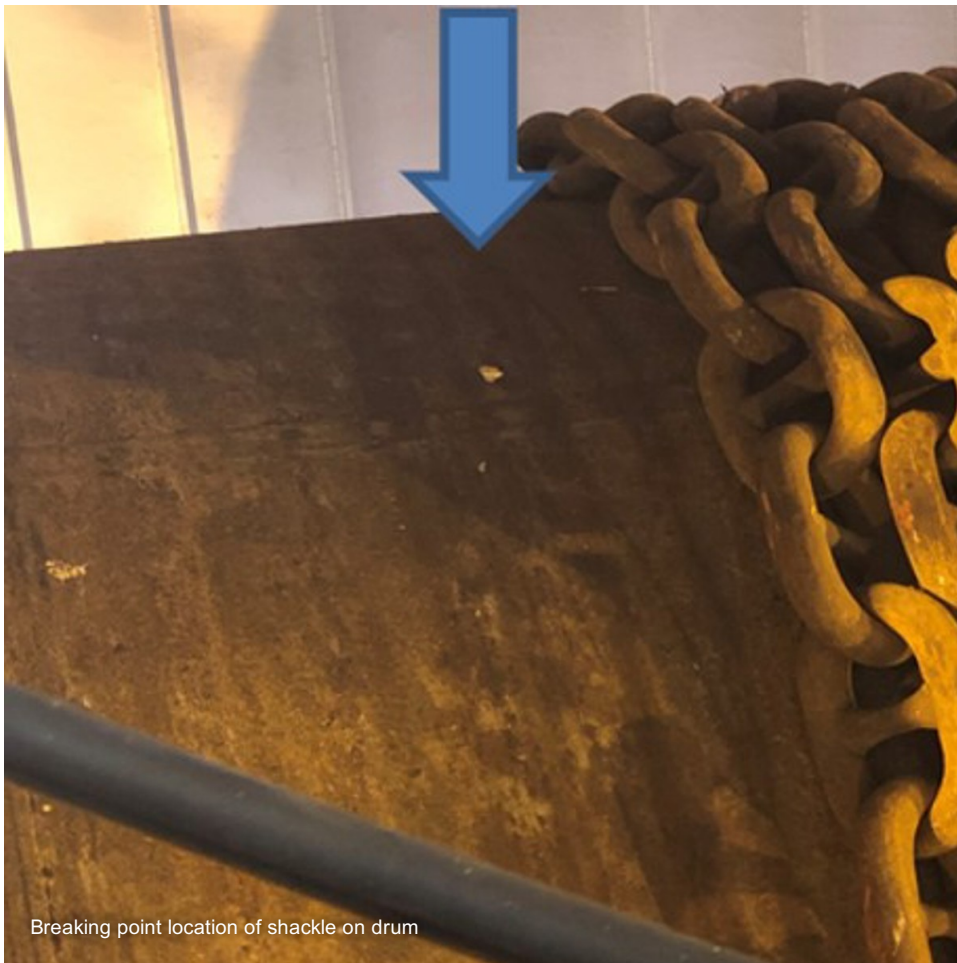
Breaking point location of shackle on drum

- Evidence suggested that during the over-boarding of the chain, the nut on the shackle pin became lodged behind the stud piece of the chain link whilst wrapped on the winch drum.
- When tension was applied on this section of the chain the links straightened and caused the nut of the shackle to be forced off along with the stud piece.
- The resultant shock may have then forced the pin out of the shackle and allowed the chain to part.
- At the point of shackle failure, the chain on the winch drum become loose and whipped towards the special handling winch causing multiple impact damage to surrounding equipment.

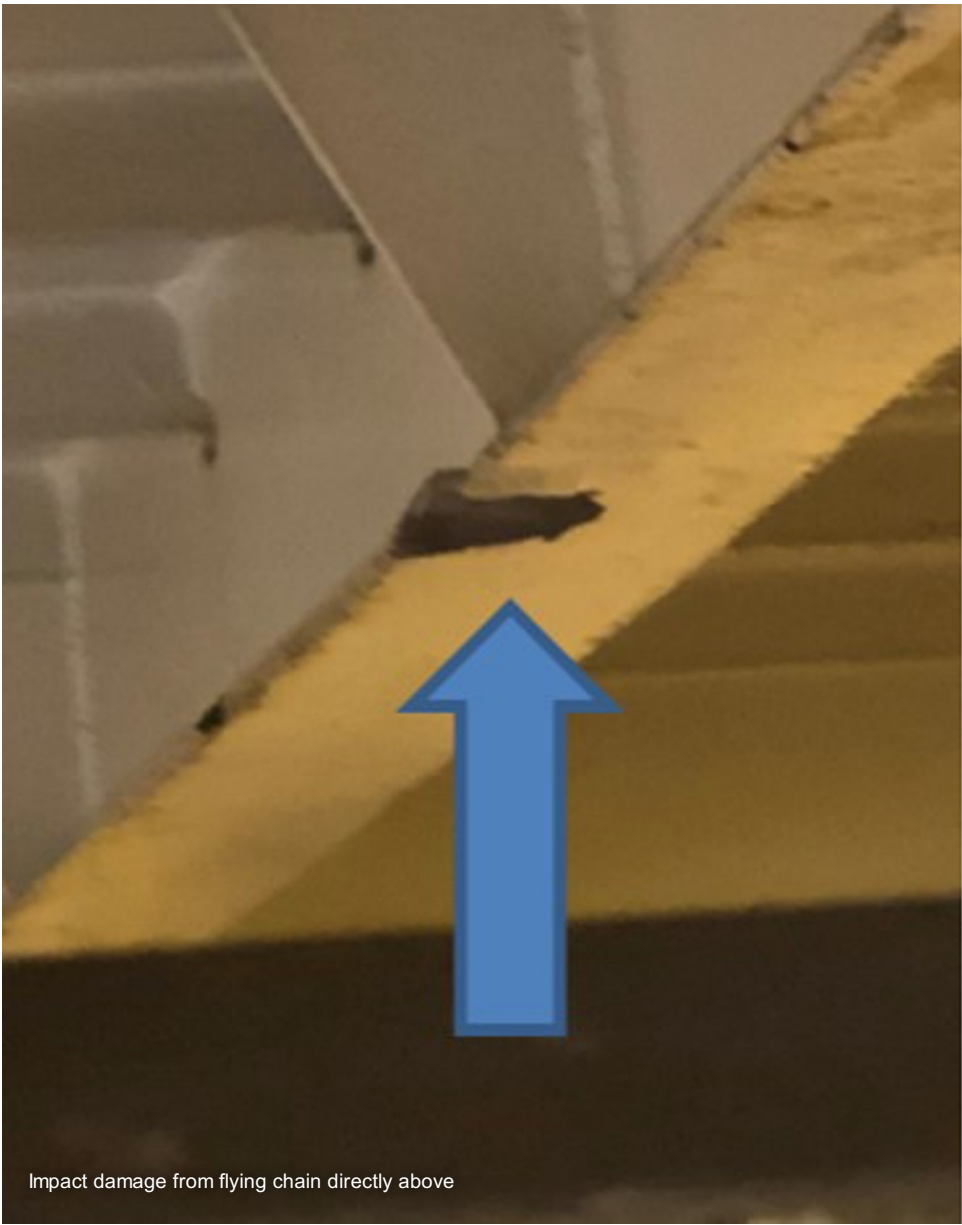
Impact damage from flying chain directly above

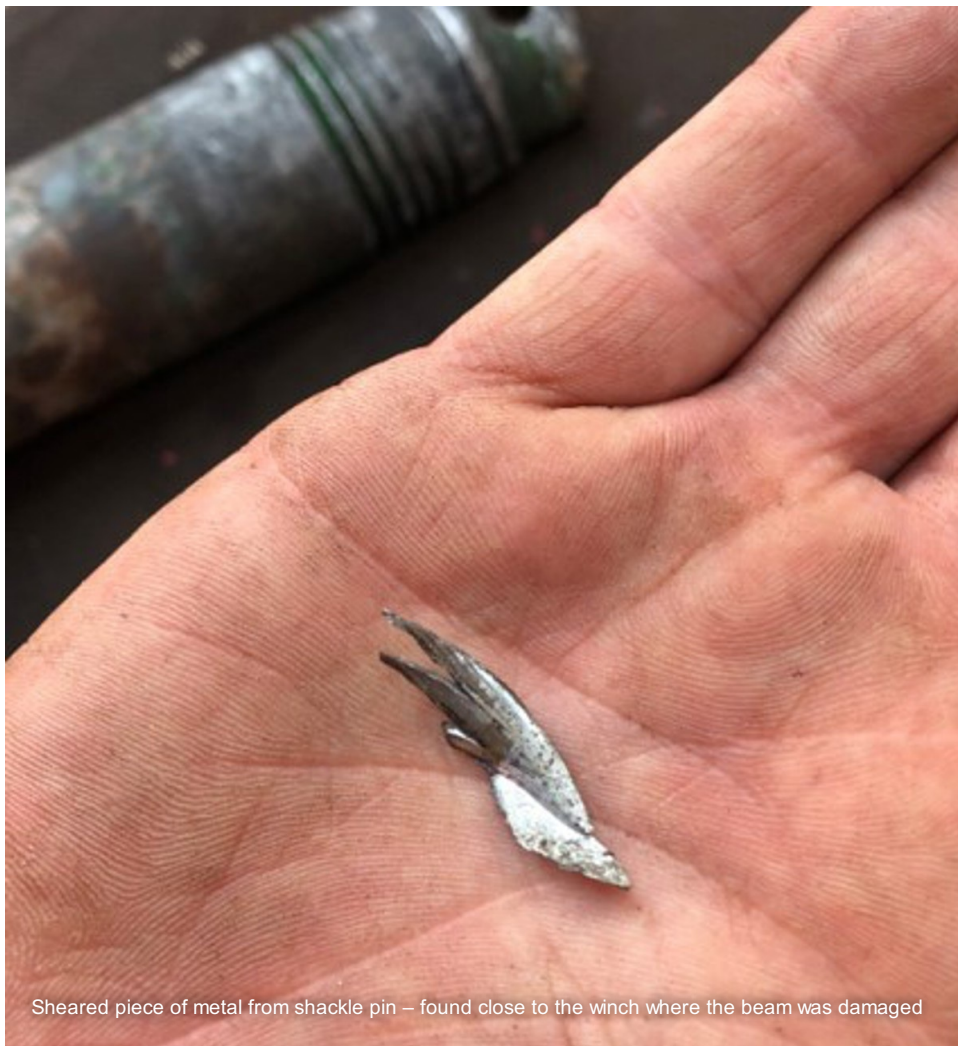
Sheared piece of metal from shackle pin – found close to the winch where the beam was damaged

**Pictures of damaged shackle nut and pin – shackle nut located STB side of winch near walkway and shackle pin found at the back of the winch.
(Clear indication the shackle was side loaded.)**
