Unplanned release of stored energy: Worker struck and injured by tensioning tool

Safety Flash Published on 21 December 2017 Generated on 16 January 2025 IMCA SF 32/17

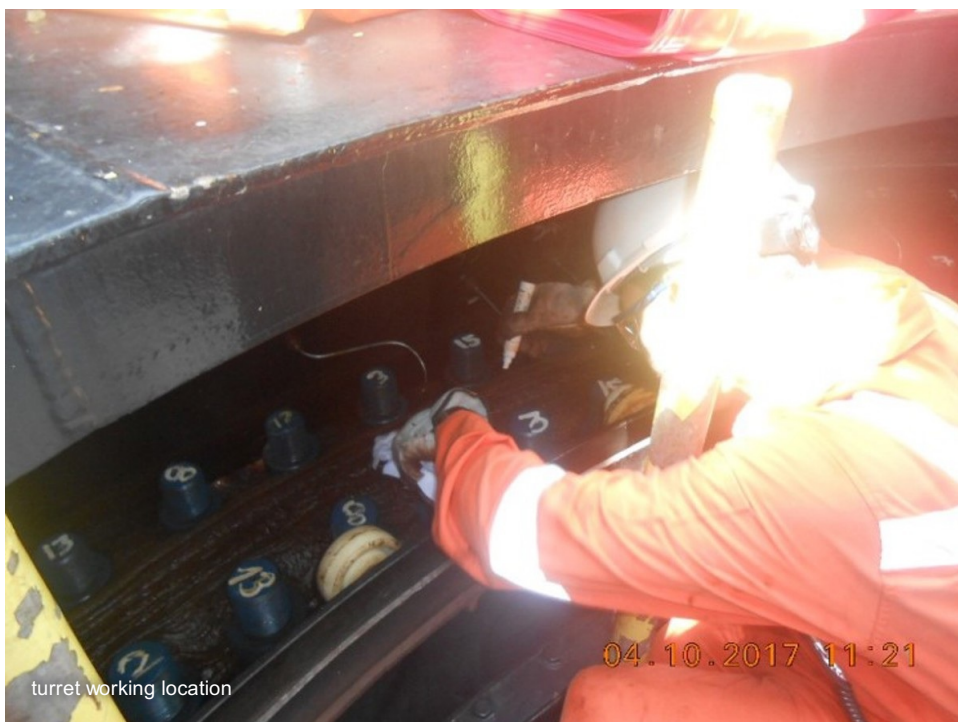
Line of fire

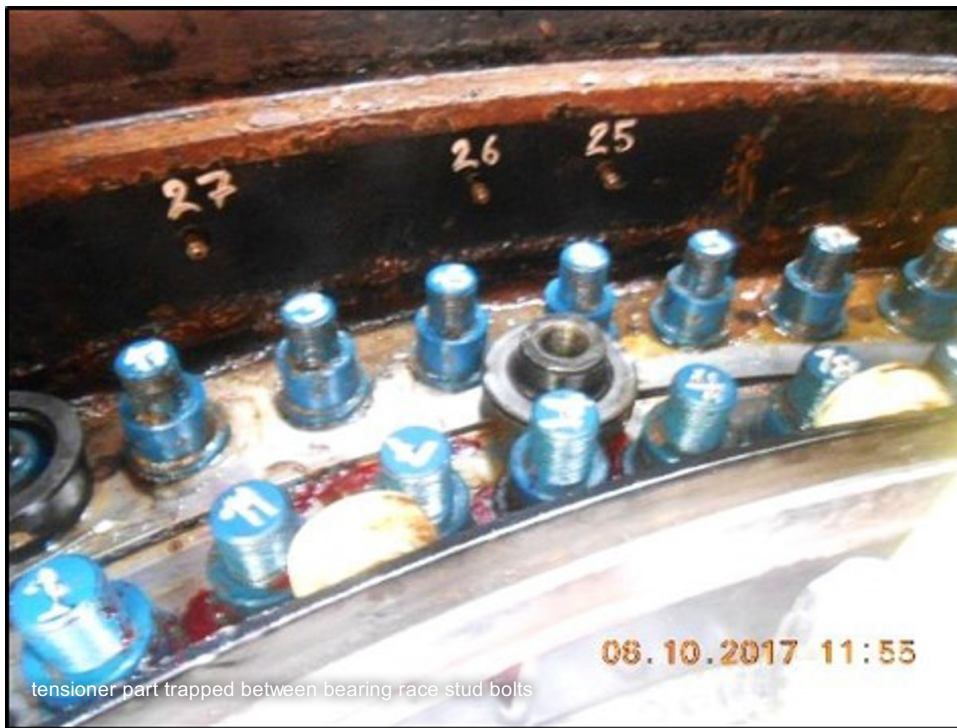
Energy isolation
