Vessel ran aground causing major hull damage

Safety Flash Published on 25 November 2021 Generated on 22 January 2025 IMCA SF 32/21

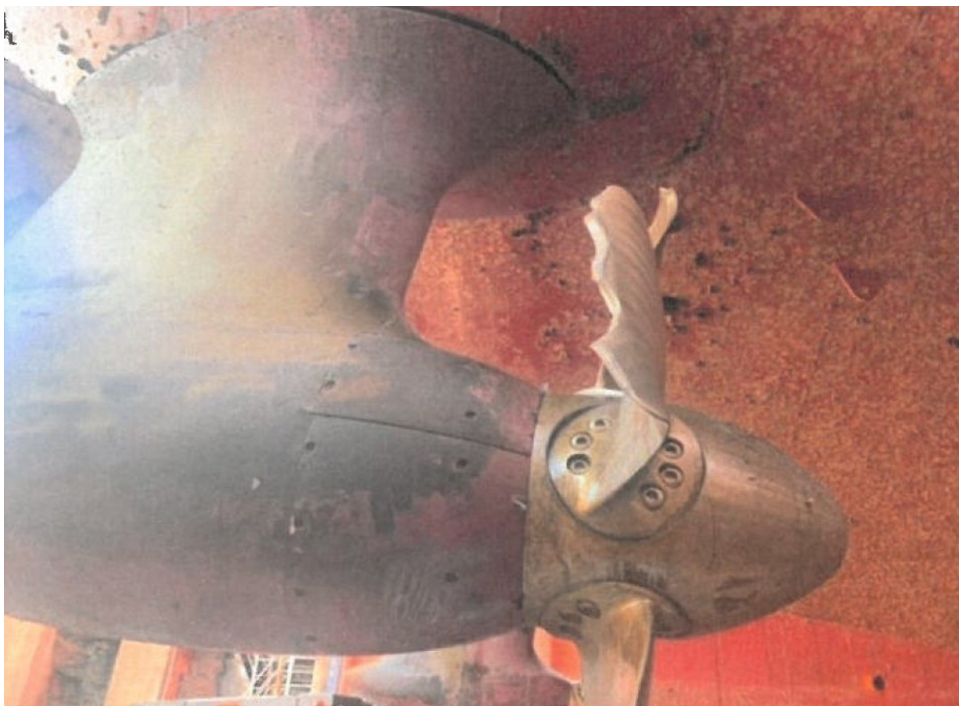
When the vessel passed the safety depth contour, she ran aground, resulting in major hull damage and damage to the propulsion system. There was a leak of hydraulic oil which was limited to approx. 40 litres. The vessel re-floated herself and returned immediately to port. The vessel had to be dry-docked as a result of the damage.

- The settings on the ECDIS were such that critical information was not being displayed.
- The vessel's passage plan was not approved in advance and used a route unvalidated in the ECDIS.
- The Officer on Watch opted to pass the vessel ahead on their port side.

- The route was not validated in the ECDIS system nor verified before departure.
- Information that could and should have been displayed in ECDIS – that is, “All Dangers” – was not selected.
- The bridge crew did not properly understand safety depth contours and the implications for the vessel of crossing them.

- Ensured that correct and appropriate ECDIS settings are part of voyage plan checklists.
- Updated bridge personnel training on ECDIS.
- Ensured deeper and fuller understanding of “safety depth contours” and the implications for vessels.
