Vessel made contact with quay

Safety Flash Published on 6 December 2016 Generated on 21 January 2025 IMCA SF 33/16

A member has reported an incident in which a vessel landed heavily on the quay, causing damage.

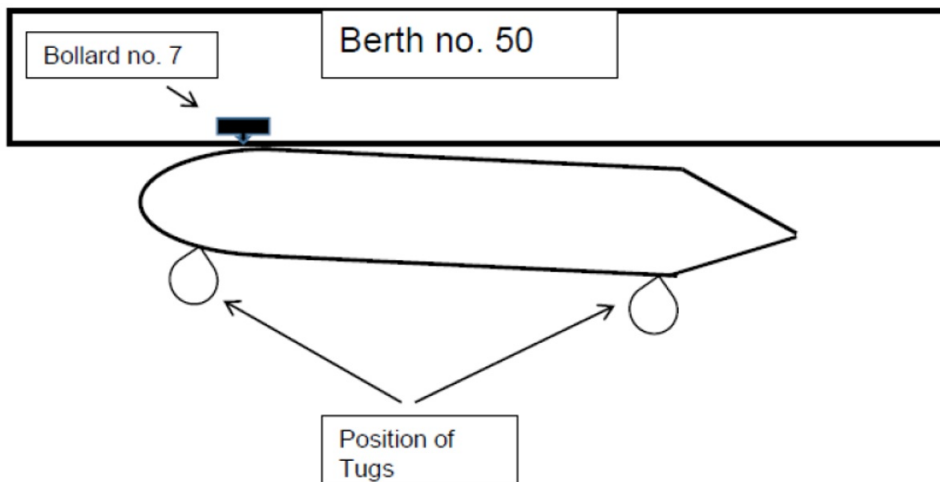
The Master requested that the Pilot take extra care as the vessel was brought alongside. However, as the vessel was being pushed towards the berth both tugs failed to push in harmony. The after tug pushed more and instead of landing parallel to the berth, the vessel's port quarter landed heavily on the quay near Bollard 7. The vessel's port side shell plating was damaged near a fuel oil tank, and there was damage to the concrete of the quay itself.

- The Pilot misjudged the tugs pushing power.
- The pilot was giving instruction in a language which was not understood by the bridge team.

A causal factor was inadequate communication – the Master failed to intervene with the Pilot when instructions to the tugs were given in a language he did not understand.

- Risk considered tolerable – this was considered by the Pilot to be a routine recurring task.
- Inadequate Standards – there were no company procedures to cover the situation, particularly with regard to the working language on the bridge during navigational operations where Pilot/tug assistance is required.

- Remind Masters that they should override the Pilot's instructions if they are considered to be incorrect or unsafe.
- Establish formal working language for ship's movement at all times including berthing/un-berthing operations.
- Ensure compliance with guidelines on relationship between Master, Officer of the watch (OOW) and Pilot.
