Man overboard incident (not fatal)

Safety Flash Published on 6 December 2020 Generated on 20 January 2025 IMCA SF 33/20

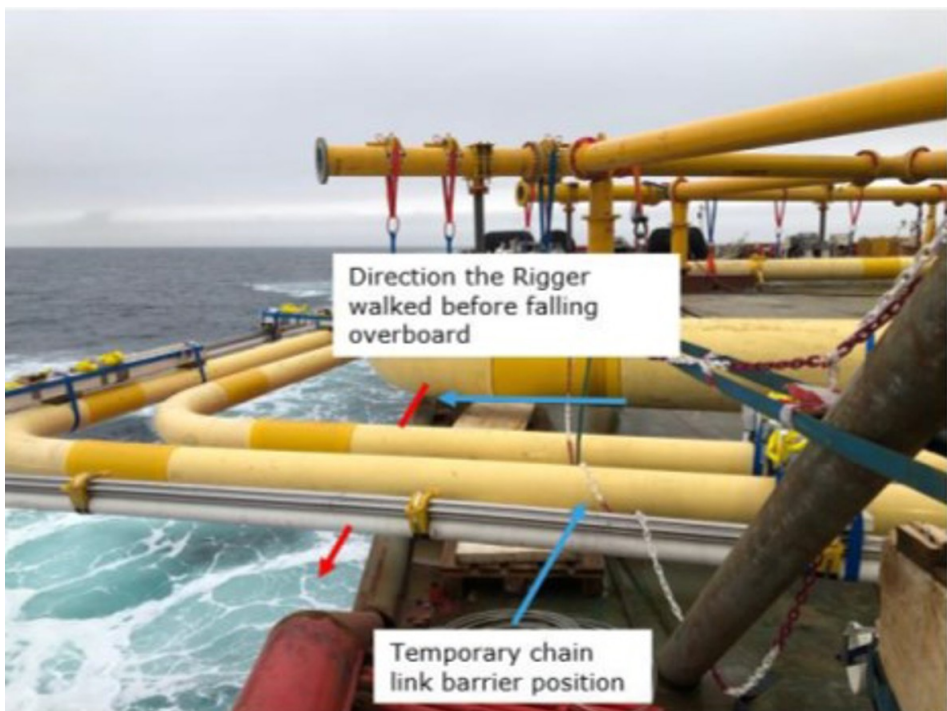
During sea-fastening of the spools a rigger decided to walk around the outside of the largest spool (see picture), without realising this was over the side of the vessel. The rigger passed through a chain barrier and subsequently stepped over the side of the vessel. The rigger was not observed falling, but his calls for help were heard.

- No rigid barriers were erected at the time of incident, only a temporary chain barrier, which the rigger passed through.

- Darkness, shadows, light transitions and poor weather (drizzle) made it difficult to see the difference between the deck and the water.
- The rigger had been on board for two weeks (with the bulwarks removed throughout that period due to multiple spool sets being mobilised) and had participated in the toolbox talk before he started work. He still did not understand the full hazard.
- There was no explicit specification that gaps should be barriered off on the starboard side (the task plan did specify a barrier for a similar situation on port side of the vessel).

- Verify that all temporary gaps and openings which create a fall hazard are equipped with rigid barriers.
- Never use access control barriers (plastic chain or barrier tape) as the single barrier for fall protection hazards.
- Review appropriateness of the use of access control barriers in particular:
 - only using these barriers for access control and not for control of fall hazards
 - warning signs used with the barrier
 - authorisation of access and egress from the barriered area.
- Check that back deck lighting is sufficient, with particular reference to areas of deep shadow.
- When project activities involve the removal or disabling of permanent safety equipment on a worksite, such as bulwarks, handrails and fire detectors for example, the project team has a responsibility to plan for an alternative and equally effective means of protection, confirming this with the worksite.
