UHMPE pull-in rope damaged during mooring connection to buoy

Safety Flash Published on 2 December 2021 Generated on 28 January 2026 IMCA SF 33/21

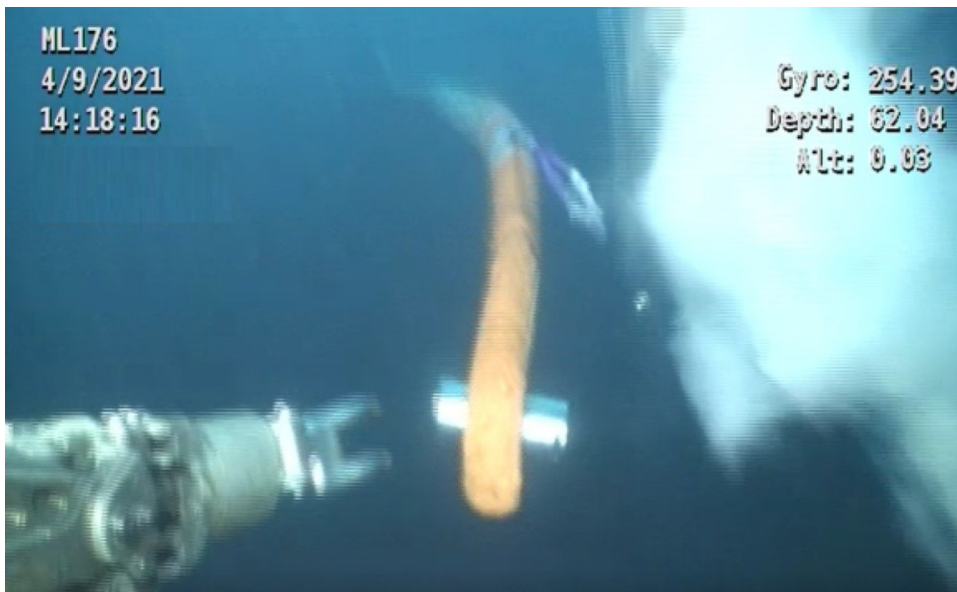
The ROV was pulling the thimble side of the rope away from a submerged turret production (STP) buoy when it lost control of the pull-in rope, causing damage to its 7-function arm. The pull-in rope was slowly paying out from a special handling winch, in combination with a capstan to overcome the friction on the full rope over the vessel deck.

Another ROV witnessed the sheave spinning very fast and the pull-in rope spooling off towards the surface, and that the thimble was stuck between the sheave and the buoy.

Slack on the pulling rope built up subsea, creating a catenary close to the vessel's port side propeller.

A combination of the sea current, pulling force of the vessel thrusters and wash

from the propulsion of another nearby vessel caused the pull rope to be ripped out of the hand of the ROV, and the other end went into the propeller which cut and damaged the rope.

- High sea current (2.8 knots) at time of incident combined with subsea conditions and the effects (wash) of nearby propulsion systems.
- There was insufficient monitoring of the pull-in rope catenary as it went over the vessel stern rollers.
- The vessel was in an unfavourable heading with respect to the direction of the current.

- The friction acting on the rope from the steel deck, was higher than anticipated.
- The synthetic (UHMPE) pull-in rope was (too) light.
- The task plan did not appropriately address the environmental conditions subsea.
- The supplier providing the mooring system confirmed that they did not consider environmental conditions during the design of the equipment.

- **Root cause** – Ineffective assessment and control of the impact the subsea environmental conditions would have on the pull-in rope during the operation, including design limitations.

The installation procedure and task plan for this work were amended, particularly with regard to the impact the subsea environmental conditions would have.
