LTI Incident – Crew Struck by Cargo During Lifting Operations

Safety Flash Published on 16 December 2020 Generated on 28 January 2026 IMCA SF 34/20

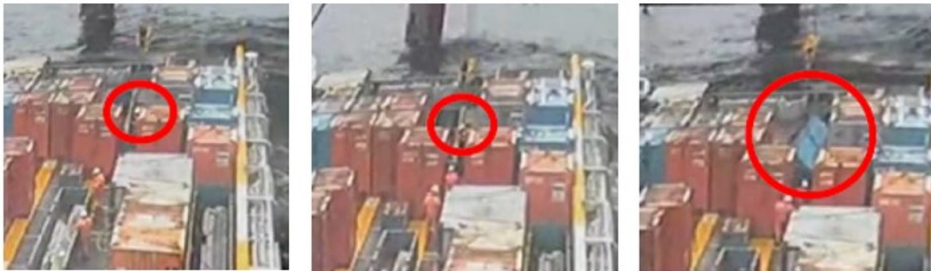
Fig. 1 - Injured person attempting to unhook load

Fig. 2 - Injured person instructed crane operator to lower the boom

Fig. 3 - Crane suddenly lifted load striking the injured person in the chest

- The crane operator did not follow the instructions of the vessel lifting team.
- The injured crew member was in the line of fire during lifting operations.
- The vessel cargo plan not followed.
- Neither the other crew members or the crane operator thought to stop the job and use their Stop Work Authority.

- Immediate Stand Down for Safety and discuss the importance of crew members staying out of the line of fire during lifting operations
- Reiteration of importance of Stop Work Authority which should be implemented if:
 - Crew see incorrect procedures being used or people working in unsafe manner.
 - Unsafe conditions are observed in the work area.
 - Crew are seen standing in a dangerous position.
- Lifting operations should not be conducted unless clear communication channels are in place between crane operator and lifting team.
