Incidents in small workboats used in the offshore renewables sector

Safety Flash Published on 20 December 2016 Generated on 21 January 2025 IMCA SF 35/16

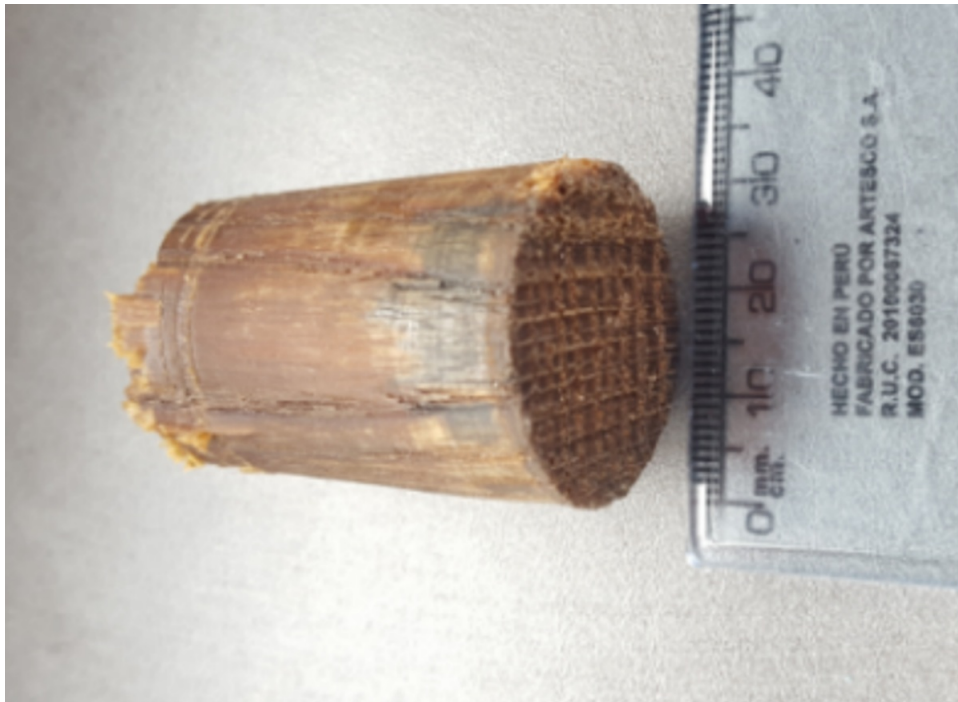
Initial investigation revealed a lack of coolant movement, causing the motor to overheat which in turn was causing the generator to automatically shut down. Further investigation (not by the crew) found a blockage was located within the coolant line. The blockage was a wooden bung.

When performing a minor repair, a wooden bung had been used to prevent any coolant loss during removal of a pipe. The repair was completed and the pipe was replaced, but without the bung being removed.

- Causal factor: poor mechanical practice.
Recommendation: ensure proper record-keeping and logging of events during repairs, particularly when repairs span several shifts, to ensure that what has

happened is clearly understood by all involved.
