Weld failure on Kirby Morgan KM17B 505-055 neck clamp

Safety Flash Published on 30 July 2007 Generated on 3 July 2025 IMCA SF 06/07

Safety Notice 1 of 2003: SL 17 A/B & MK 21 Neck clamp 28 Aug. 2003

Subject: Neck Clamp Assembly KMDSI Part # 505-055 (and pre '89 505-003)

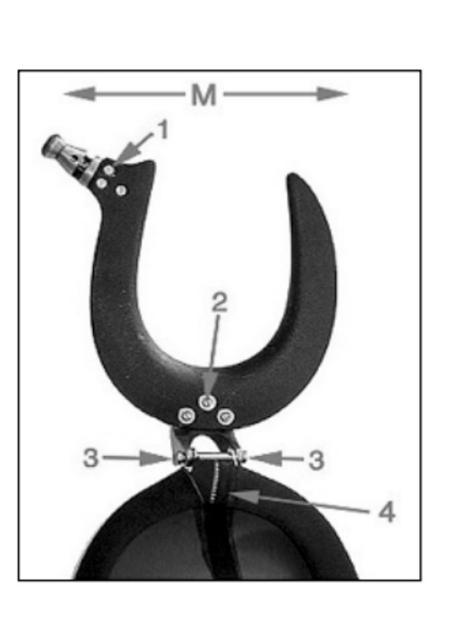
As the neck dam ages it compresses and the clamp must be adjusted by tightening the adjustment locking nut (E) so that the clamp operates as described above.

The stainless steel nylon lock nut (E) will require periodic replacement as the nylon insert wears out due to the periodic adjustments to the clamp that MUST be made as the neck dam ages or you change to a dry suit mount. YOU SHOULD NEVER HAVE TO FORCE THE CLAMP SHUT!

Proper adjustment of the neck clamp should place the bail squarely in the groove of the latch catch body when the clamp is closed.

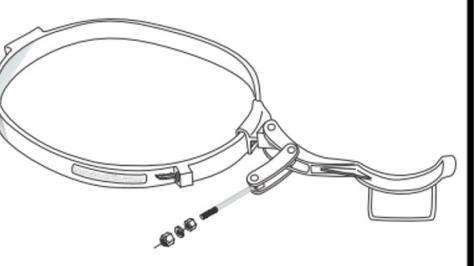
Kirby Morgan Dive Systems, Inc. (KMDSI) was alerted by its Authorized Dealer in Southern Africa about the following incident: A Kirby Morgan SuperLite 17A/B (Serial #82929, purchased in April 1997) neck clamp assembly was found jammed in a container door. The neck clamp was hanging on the umbilical rack on the door and the person closing the container door did not notice that it was jammed. When the jammed neck clamp was discovered, it was removed and closely inspected.

During the clamping process (onto the helmet) one of the welded pins on the neck clamp assembly broke off. On closer inspection it was noted that there was no way of identifying this potential break as both sides of the pin are welded.

It is important that a visual inspection of the neck clamp assembly be done before every dive. Normal inspection of the neck clamp assembly is covered in the Kirby Morgan Daily Pre-Dive inspection Appendixes A2.3, Monthly Inspection A2.2 and the Annual / 400 Hour Overhaul A2.1. These Appendixes can be found at www.kirbymorgan.com">http://www.kirbymorgan.com, www.kirbymorgan.com under notices/maintenance checklists.

The Annual/400 hour Overhaul has the technician remove the clamp from the yoke and neck dam so that all the component surfaces are revealed for inspection. The monthly Inspection check has the technician checking all welds and checking the entire clamp adjustment stud by loosening the lock nut and exposing the entire stud. This check is not as complete as the annual but is considered adequate if done monthly. Neck clamps older than five years should be inspected weekly in accordance with Appendix A2.2 steps 1-6 and daily in accordance with Appendix A2.3 Daily Pre-Dive Set up and Inspection steps 1.1-1.2. Anytime neck clamps are used on different helmets the neck clamp must be checked for proper function, fit and adjustment prior to diving.
