<i>Product Awareness Notice</i>		
Doc. no.: 1252		date: 12.02.2008
Doc. distributed to:	Customers having this equipment. USH Service Engineers, USH Service Partners, USH Claims Coordinator, USH Management.	
<i>NB!! Implied customers should be informed of this document</i>		
Manufacturer:	Umoe Schat-Harding Harding AS, Umoe Schat-Harding SRO	
Product:	Free-Fall Hook type FFH13	
Production Period:	all up to this date	
Improvement Note Ref.:

**Advice of inspection.**

<i>Product Awareness Notice</i>		
Doc. no.: 1487		date: 14.01.2009
Doc. distributed to:	Customers having this equipment. USH Service Engineers, USH Service Partners, USH Claims Coordinator, USH Management.	
<i>NB!! Implied customers should be informed of this document</i>		
Manufacturer:	Umoe Schat-Harding Harding AS, Umoe Schat-Harding SRO	
Product:	Free-Fall Hook type FFH13	
Production Period:	all up to this date (1999-2009)	
Improvement Note Ref.:

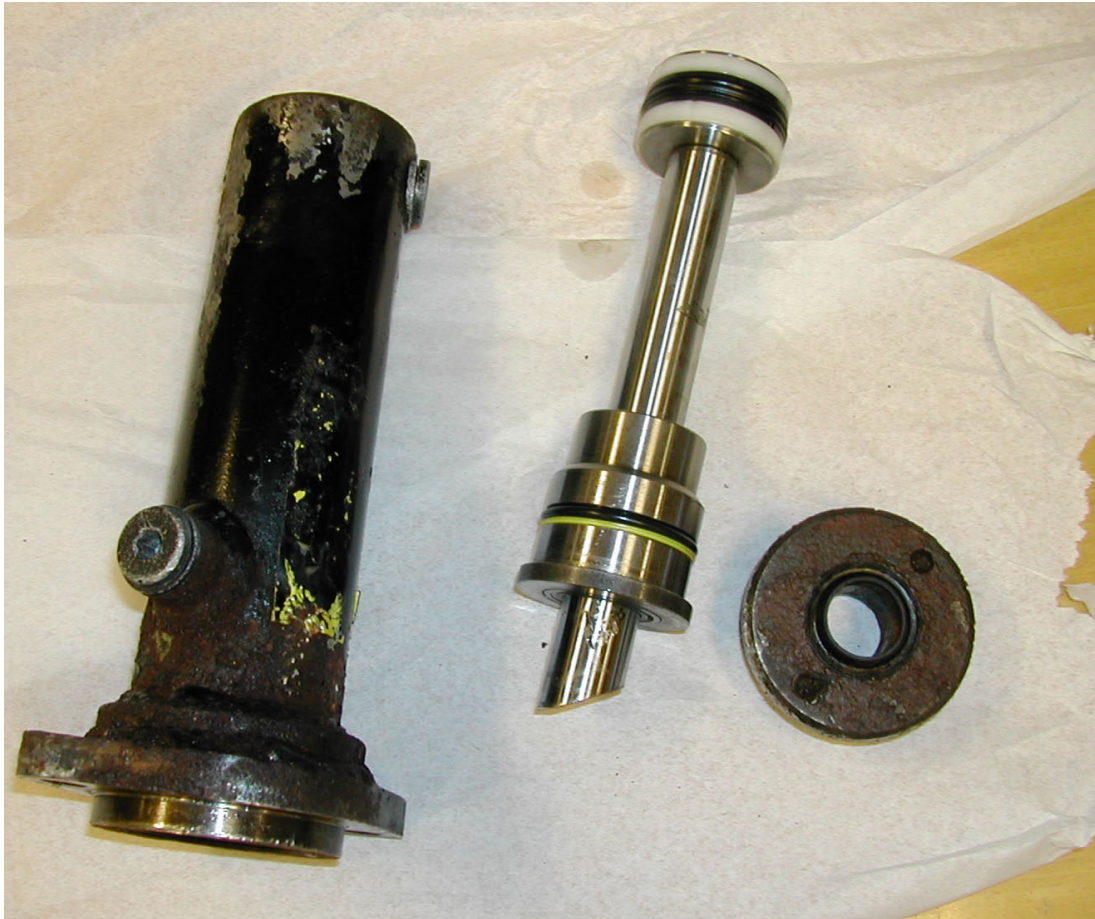
Picture 1.

The piston rod was cut in order to manage to disassemble the hook. Cylinder to the left and the end piece to the right.

The hydraulic cylinder was changed and further examination revealed that the piston rod was stuck to the cylinder end piece by corrosion. The cylinder end piece is of normal steel, and as the enclosed pictures shows that the outside is clearly corroded due to that the applied painting is not sufficient to protect this part. On the inside one we also see corrosion and a damaged area on the piston rod which we believe is where the rod was stuck to the end piece. To avoid this situation there should be hydraulic oil inside in the cylinder both in the high pressure side and in the low pressure side, but it seems that there has not been oil or that some water has entered the seal in the cylinder end piece.

A mock training freefall should be carried out as soon as possible (according to given instructions) in order to verify that the cylinder and the hook is operating as it should. The hydraulic cylinder should then be inspected that it moves when pressure is applied. If the cylinder is not operating, please contact our Aftersales and Service Department for assistance. The hook arrangement including the hydraulic cylinder should be operated and tested according to given instructions at a regular time interval.

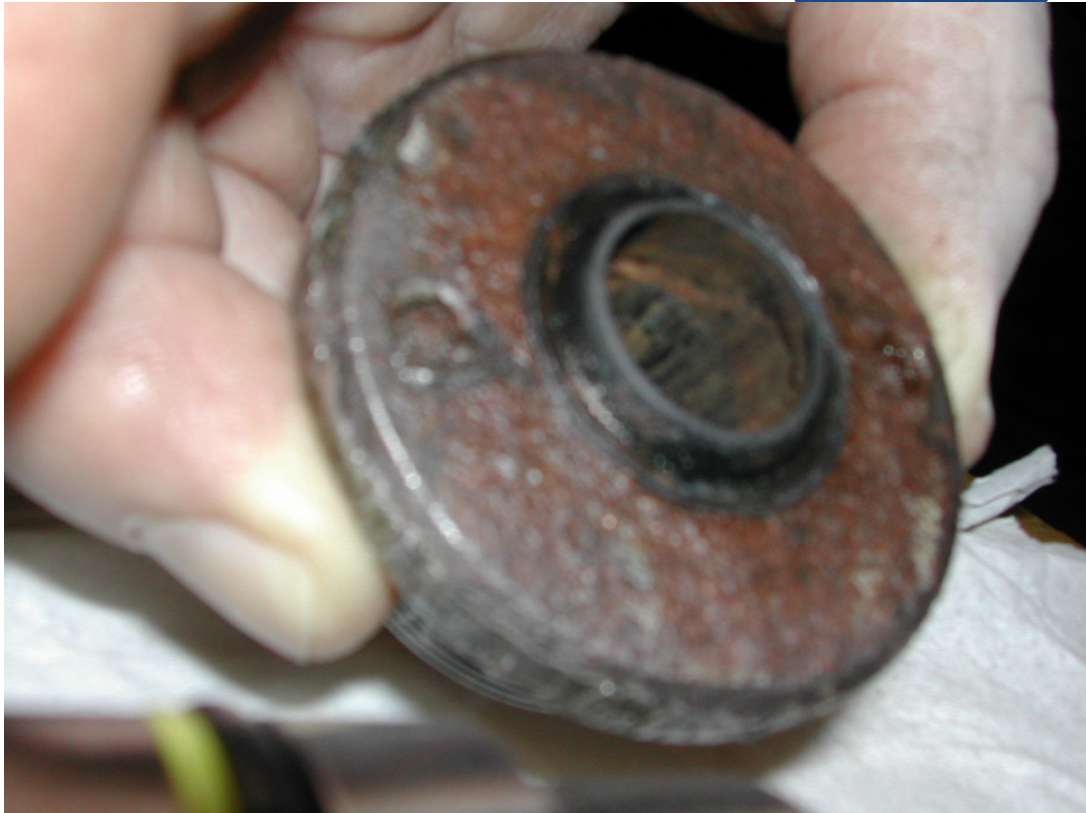
Picture 2.  
The end piece is corroded, also on the inside.

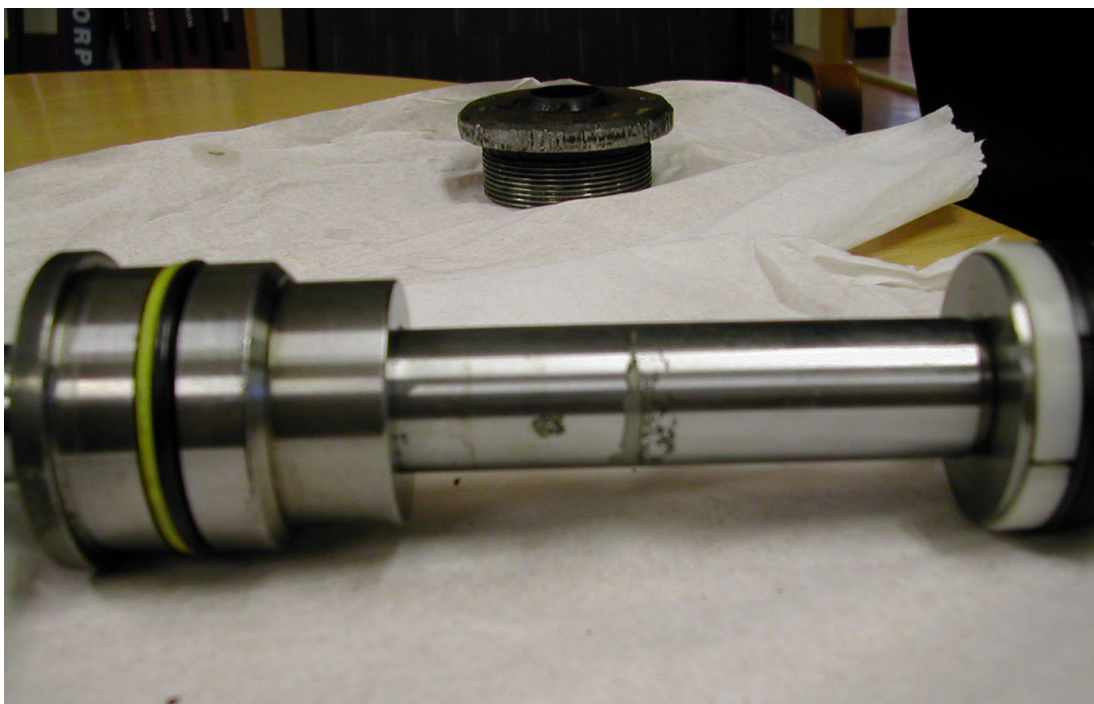
Picture 3.  
Piston rod has clearly a damaged area.
