Marine Safety Forum – Safety Flash 09/12

Subject: Lifeboat D-Ring Failure

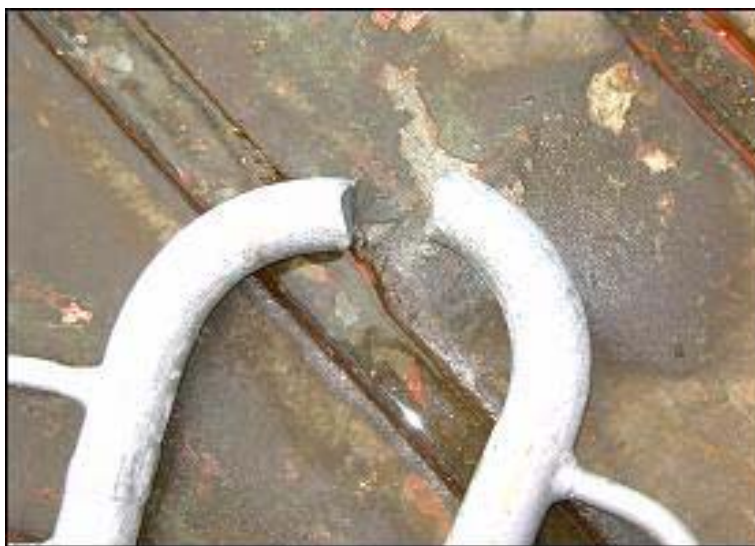
A recent incident in offshore operations highlighted some actions related to lifeboat/Fast Rescue Craft (FRC) maintenance that should be taken immediately. During the incident, the lifeboat fall D-ring failed while load testing the lifeboat and wire fall assembly. It was found that the failed D-ring was non-OEM (Original Equipment Manufacturer) and was of welded construction rather than the forged construction originally supplied by the OEM.

- 1) Only use OEM equipment on new and existing lifeboat/FRC and lifeboat/FRC fall assemblies, except when changes have been subject to the appropriate MOC and approved by the relevant Marine Authority; and
- 2) Conduct all load testing, maintenance and inspection of lifeboat/FRC and lifeboat/FRC fall assemblies using detailed procedures that have been subject to a risk assessment and approved by the relevant Marine Authority.
