Marine Safety Forum – Safety Flash 11-31

Subject: Engine Room CO2 Isolating Valve

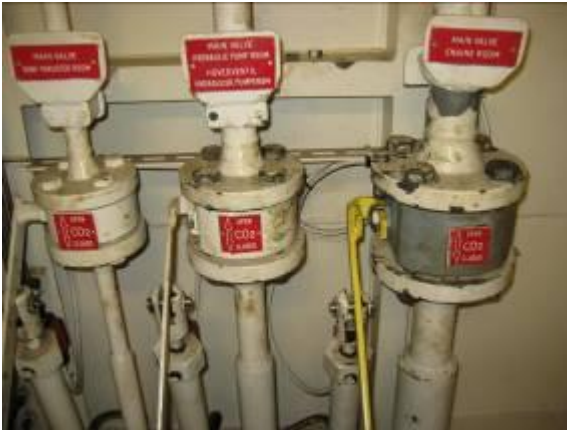
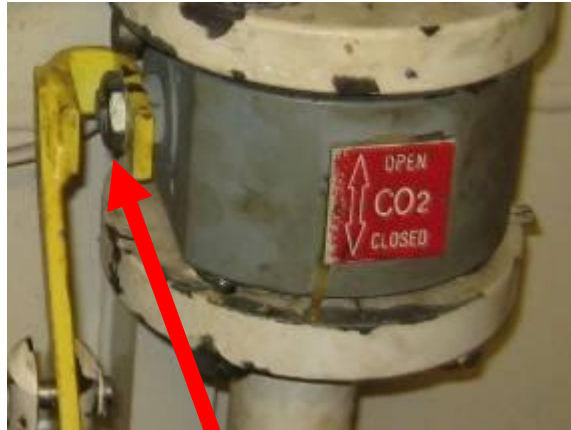
During routine inspection of a vessel's CO₂ fire fighting system it was noticed that the engine room CO₂ isolating valve remained in the closed position when the valve handle was manually operated. This was evident by the position of the valve spindle which remained in the closed position whilst the handle showed that the valve was open.

Spindle remained in the closed position
whilst the handle was in the open

In the event of a fire and the need for CO₂ flooding, the isolating valve handle would have been forced to the open position, whilst the valve itself would have remained shut, thereby disabling CO₂ flooding.

The isolating valve was removed, freed up and the handle was repaired and tightened. During this repair process the safety pins for the CO₂ bottles were put in place and removed once the repair was completed.

All vessels must ensure that these CO₂ isolating valves open and that it is not just the handles turning on the valve spindles. All vessels are instructed to add a line of instruction to the TM job for checking that this valve is operating correctly when the inspection is done on the CO₂ system.
