First aid injury: Contact with spinning spooler arm

Safety Flash Published on 18 January 2013 Generated on 12 January 2025 IMCA SF 01/13

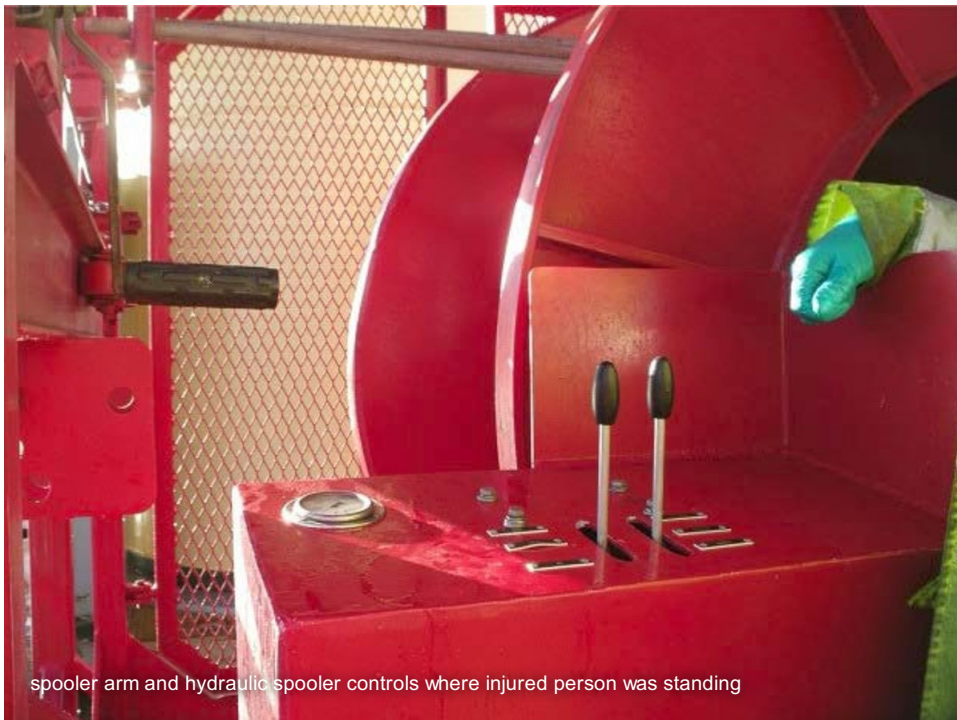
As the grapple was being lifted inboard the vessel took a heave, which pulled the hoses tight causing the handle on the spooler arm to spin round. As the handle spun it caught the third party technician on the upper arm, wrist and knuckles. The technician was wearing full personal protective equipment (PPE) at the time but was taken to the medic, where he was checked over and found to have light bruising.

spooler arm and hydraulic spooler controls where injured person was standing

- Use of an automatic spooler would prevent the need for hand/body positioning so close to the spooler arm handle during recovery of the grapple.
- In addition to ergonomic issues, it was found that personnel were exposed to environmental hazards, i.e. the weather, when operating the controls. Adapting this area to include some form of habitat would mean operators were protected from the weather.
