High potential dropped object - cradle falls from trailer

Safety Flash Published on 12 January 2026 Generated on 28 January 2026 IMCA SF 01/26

A large “cradle insert” weighing many tonnes fell off a trailer during a lifting operation.

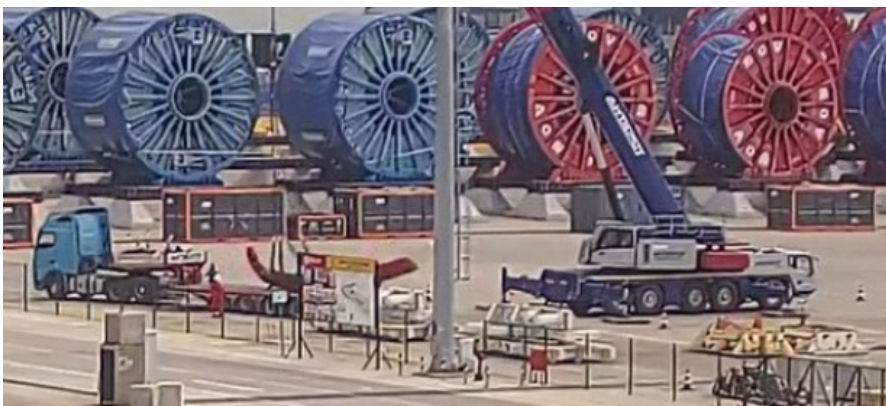
The incident occurred during the offloading of two the cradle inserts from a vessel alongside. The cradle inserts were secured together with cargo straps and rigged with a 4-legged chain bridle. As the crane operator began lifting, the inserts then unexpectedly fell off the right side of the trailer before the rigging was fully tensioned, landing near the crane.

CCTV footage showing the cradle insert falling from trailer

- Crew were in the line of fire, because the lift was not planned and managed effectively.

- Clearly understood communications protocols were not established.
- Inadequate communication between the lift banksman and crane operator led to the lift not being stopped in time, resulting in sling interference.
- The banksman was also acting as a rigger rather than keeping an oversight of safety.
- The poor stability/high centre of gravity of the load went unrecognised as a risk; this led to the load being stored vertically with minimal contact on the trailer and made them highly likely to fall.
- Securing straps were removed prematurely, leaving the load unsecured during a critical phase of the lift.

- Insufficiently thorough or detailed lift planning, which failed to assess the load's complexity and stability. The upright storage method wasn't critically reviewed, and assumptions were made without reassessment.
- Flawed design of the cradle insert, which had minimal support, making it unstable when upright.
- Incomplete and inaccurate lift documentation. Critical data like centre of gravity and rigging details were missing or wrong, causing poor decisions.

- Ensure appropriately thorough, specific, and detailed lift planning.
- Take special care when planning the lift for objects that may initially look simple – be aware of hidden complexity;
- At design level, ensure lifting points and Centre of Gravity are clearly marked on drawings.
- At the point of lifting, ensure that the Centre of Gravity and geometry of the lifted object are fully understood by everyone involved in the lifting operation.
- Check – what are your escape routes and safe zones?
- Establish clear communication protocols.
- The banksman should never act as a rigger.

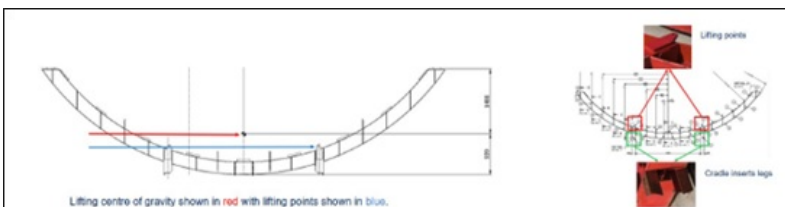
Showing the centre of gravity and associated supports/lifting points
