Injury involving contact with a vehicle battery

Safety Flash Published on 1 February 2003 Generated on 17 February 2026 IMCA SF 02/03

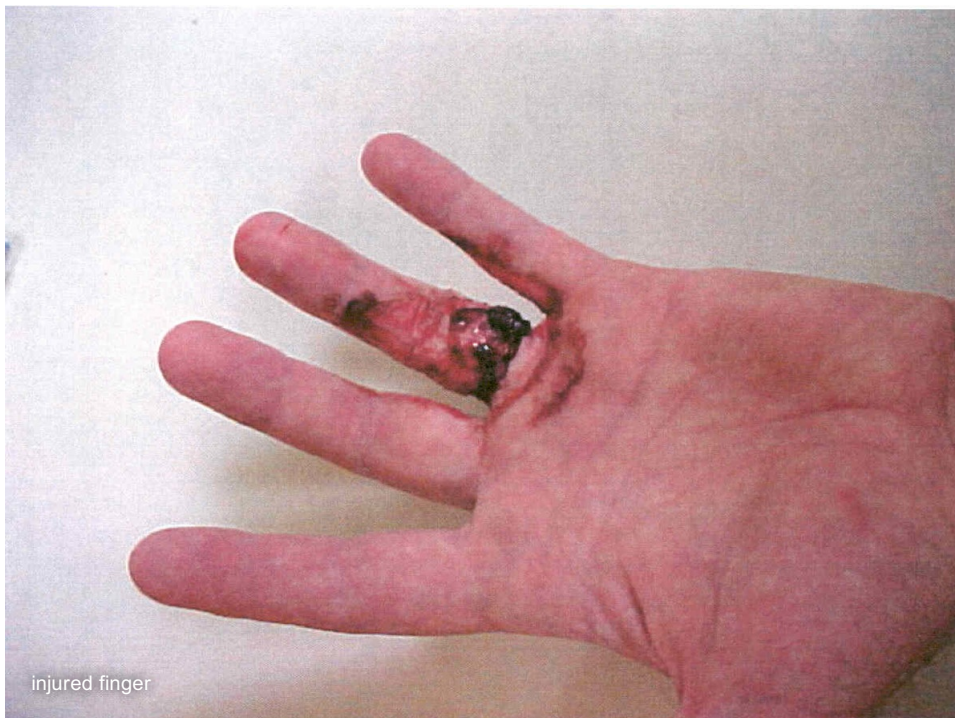
A 12 volt vehicle battery was being disconnected using a crescent wrench, which slipped and grounded out when it came in contact with metal.

The person received a burn on his ring finger as his gold ring had come into contact with the wrench. The injury was completely around the ring finger and severe enough to cause concern about the loss of the finger from a lack of adequate circulation.

It has been pointed out that most vehicle batteries have 600-800 cranking amps, compared to 75 amps for stick welding and 300 amps for air arc welding. Severe burn injuries can occur and caution should be exercised when handling such batteries, including removing rings and other jewellery before starting work near or on a battery/connected wires and equipment.
