Failure of life raft securing strap

Safety Flash Published on 10 January 2020 Generated on 14 January 2025 IMCA SF 02/20

A life raft from the starboard forward life raft station made an unplanned deployment into the sea

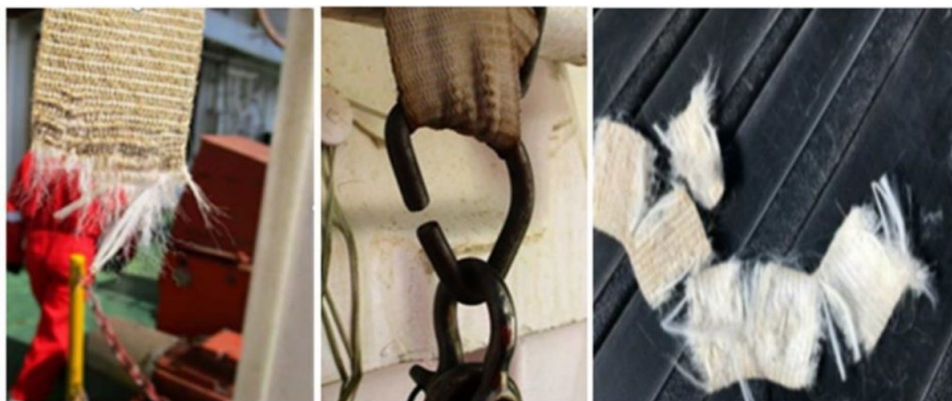
Photo 1
Image of sling after the life raft deployment, as found.

Photo 2
The sling parted in the buckle at its weakest point.

Photo 3
The sling material was found to be fragile and parts easily, suggesting UV degradation.

There was a failure of the securing straps designed to hold the life raft in place.

This allowed one life raft to deploy into the sea. The securing straps had only been installed one-year prior to failure.

The vessel was in operation in the Middle East, with high temperatures and high UV levels.

The hold back strap, used to retain the life raft in place, was found to be degraded to the point of failure.

This appears to have been caused due to the extremes of temperature and ultraviolet light.

Inspection routines for life rafts and associated lashings should consider the environmental conditions, and all parts of the equipment should be visually inspected and maintained at appropriate intervals.

Assumptions should not be based on vessel operating areas; UV damage may occur within any region.

- Conduct immediate inspections of life raft securing straps and associated equipment.
- Replace any items which are of concern or appear to be faulty.
- Verify manufacturer's instructions with regards to the service life of the securing straps.
- Any temporary secondary securing arrangements should not affect the ability to launch any life raft – as per SOLAS requirements.
- Members may wish to refer to UK MCA Guidance note MGN 343 Hydrostatic release units: stowage and arrangements for liferafts.
