Near-miss: Hyperbaric fire extinguisher incident

Safety Flash Published on 4 April 2007 Generated on 17 January 2025 IMCA SF 03/07

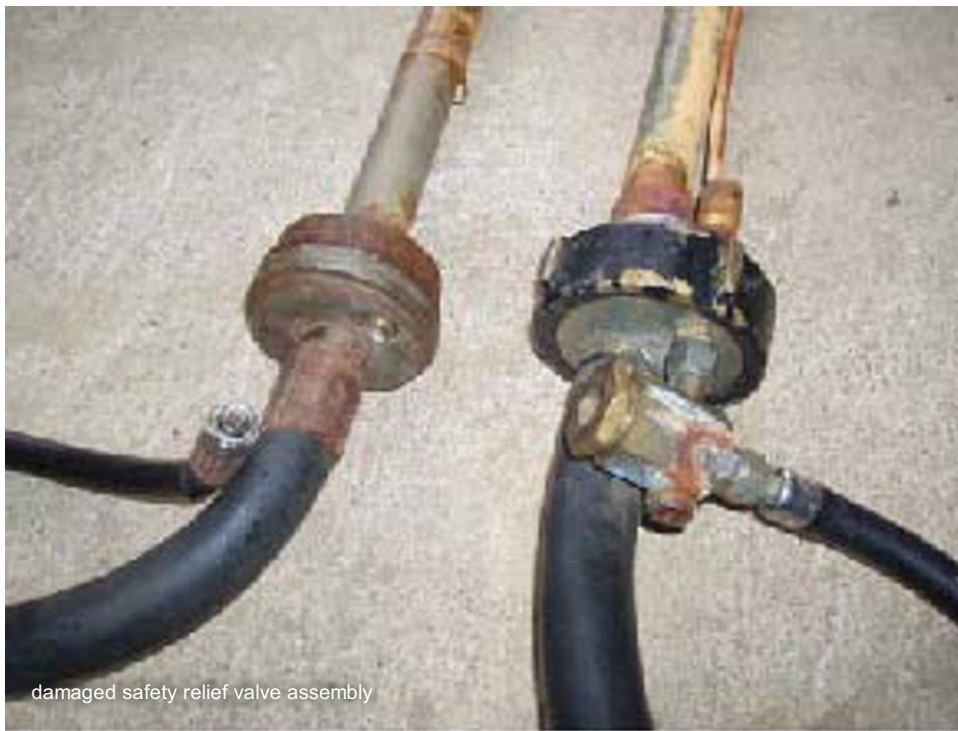
A mechanical technician was carrying out regular six-monthly checks on the fire extinguisher in the base workshop. The technician opened the high pressure cylinder valve with the intention of checking the function of the unit. As per the design and functionality of the extinguisher, the gas from the high pressure cylinder passed through a step-down regulator set at 9 bar and entered the low pressure tank, which contained the fire-fighting medium, in this case an emulsifier. At this point the entire safety valve assembly blew off the top of the low pressure tank at the point of the penetration fitting. The safety valve assembly was not recovered after the incident. No-one was injured.

Upon checking the first stage regulator it was found to be faulty. The burst disc on the safety valve assembly was also found not to function as pressure built up due to a faulty first stage regulator.

damaged safety relief valve assembly

- It has introduced a policy of phasing out twin gas cylinder extinguishers and replacing them with single bottle hyperbaric cylinder extinguishers, which are considered safer and are widely used in the industry.
- The burst discs on safety valves are to be replaced on yearly basis.
- It has noted that equipment tracking needs to be good enough to enable tracing back of particular pieces of equipment such as fire extinguishers.

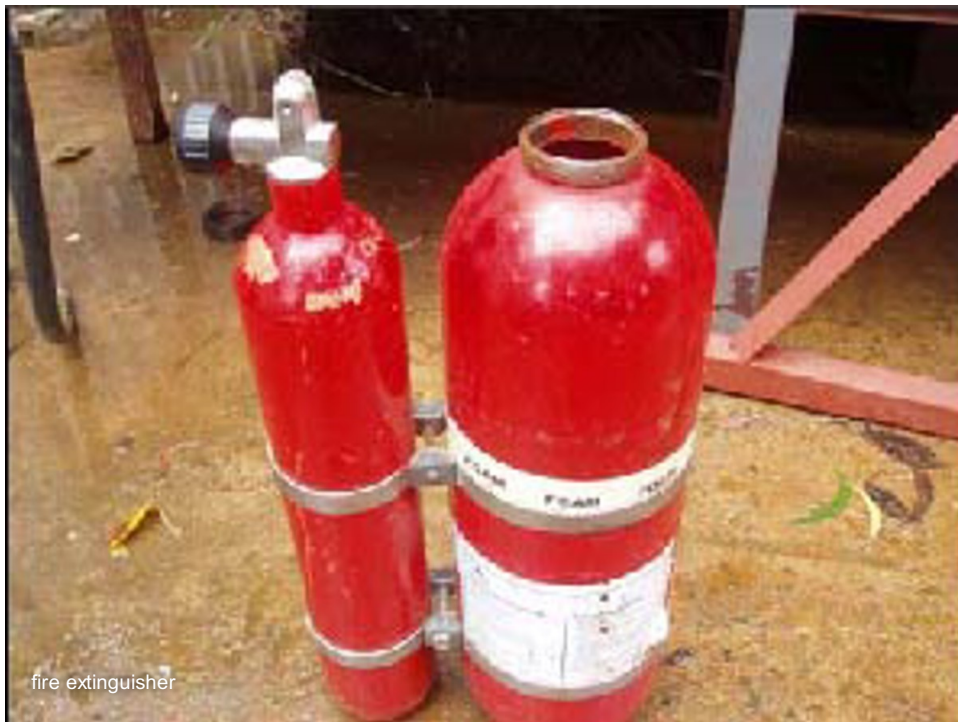
A Member has reported a near-miss incident in which the safety valve assembly of a twin cylinder hyperbaric fire extinguisher blew off during 'routine' checks.

fire extinguisher
