Badly sprained ankle resulting in LTI

Safety Flash Published on 8 May 2015 Generated on 24 January 2025 IMCA SF 06/15

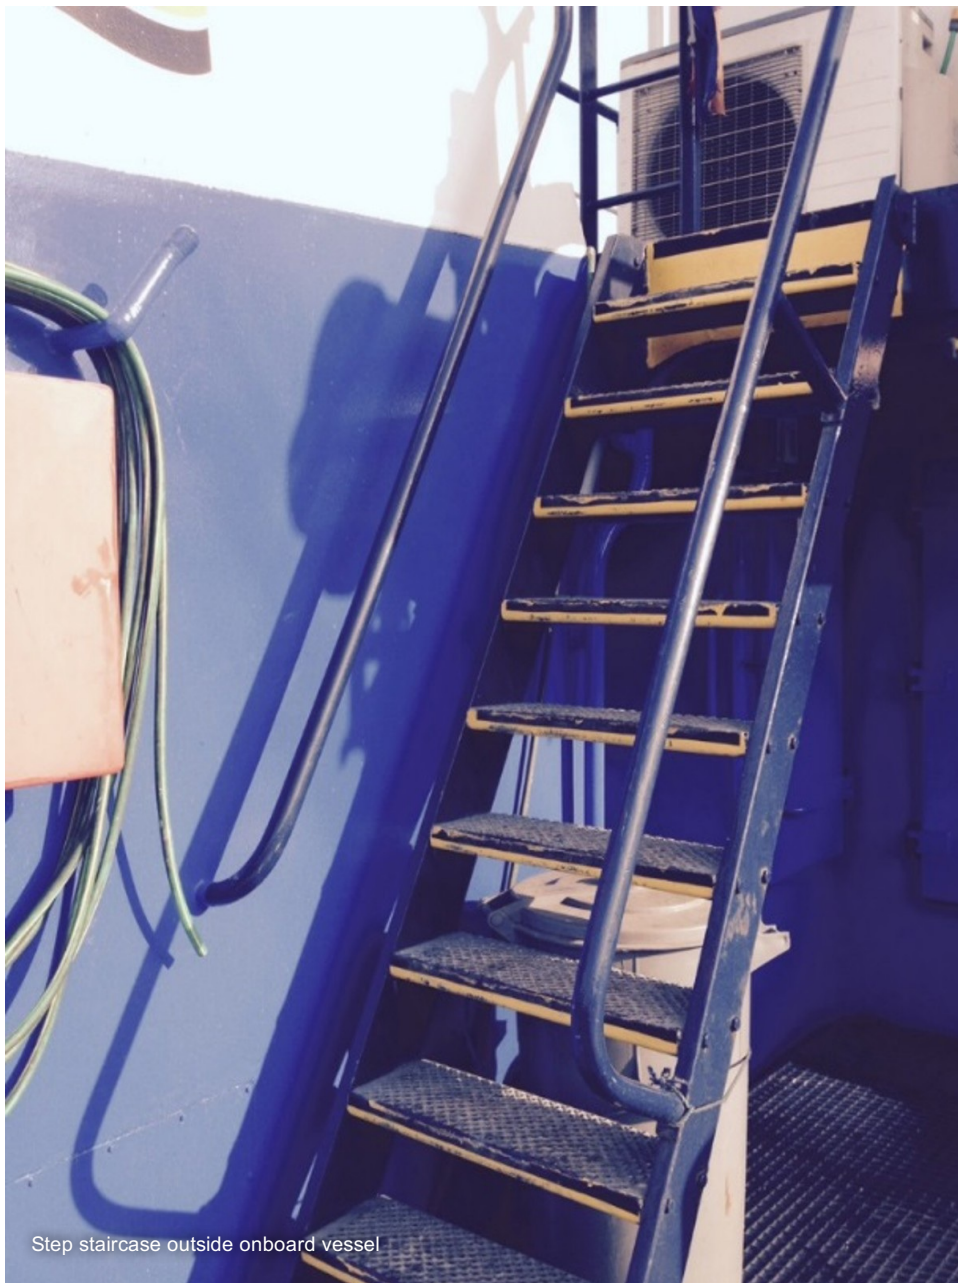
The incident occurred when the person was making his way from the wheelhouse to the galley via the external staircase. When he put his weight on the second step his foot slipped and he fell the remaining distance (approximately 2 metres) to the deck resulting in an ankle injury.

Step staircase outside onboard vessel

- Conditions were wet at the time.
- Other than being wet, the steps were clean.
- The injured person fell without hitting any other steps on way down and took the full impact on his foot when he hit the deck.
- The injured person was descending facing away from steps.
- The design of the stair (approx. 40 degrees from vertical) meant that when descending in this manner, only the person's heel could be placed on the tread.
- Steep stairs were not identified as a hazard on this vessel.
- The injured person was wearing correctly fitted, laced/zipped work boots with good tread, and was not carrying anything at the time of the fall.

- Individuals should always consider the safest method of descending stairs before doing so.
- Stairways to be kept clean, and where possible, non-slip treads/nosings fitted.
- 'Caution steep stairway use handrails' signage fitted.
- The fact that you have not been told how to descend the stairs does not remove the need for you to assess your own safety before descending, and decide how to descend the stairway.
- Ensure hazards not directly linked to operational tasks, are considered and addressed in the workplace, and included in vessel induction for all crew, client personnel and passengers.
- Ensure that work boots and all other PPE is fitted and worn correctly.
